LELAND DAM INSPECTION

Dam Identification No.: 510
Hazard Potential: High
NE Quarter of Section 9, T. 30 N. – R.12 W
Leelanau County, Michigan
Lake Leelanau

Date of Inspection: September 1, 2022
Date of Report: October 2022

Project I.D. Number 131999SG2022

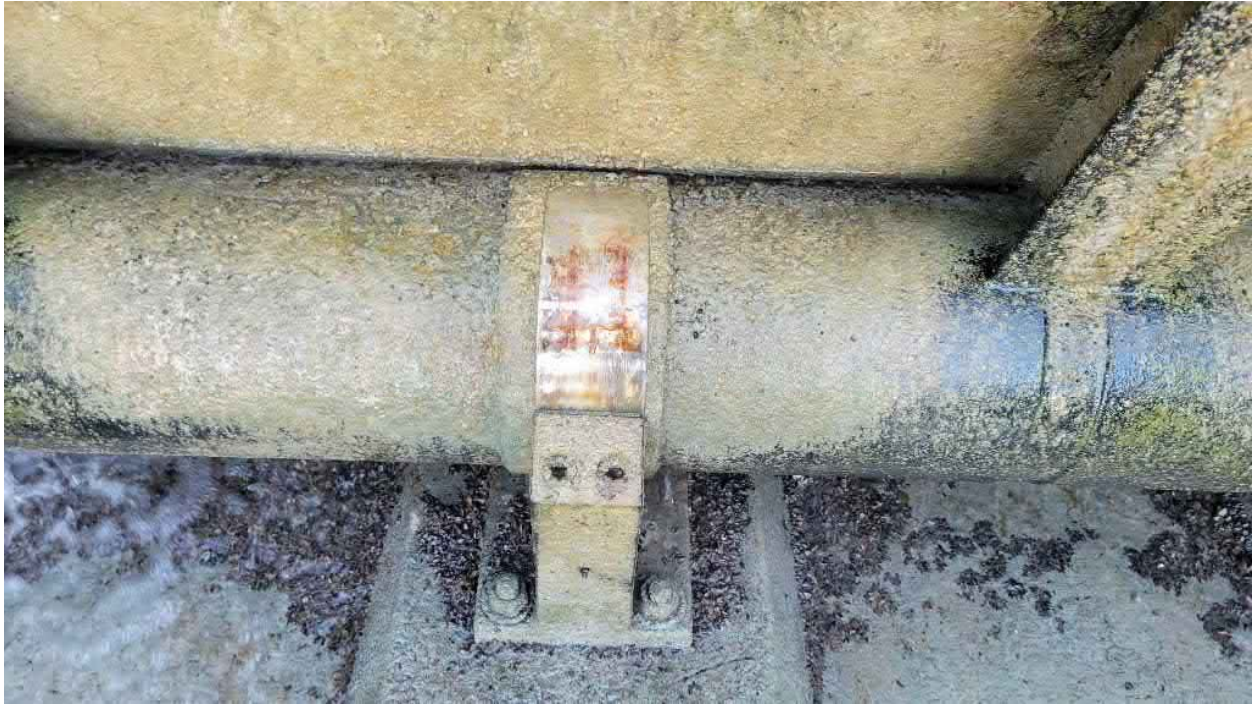
Joint Observation - Corrosion

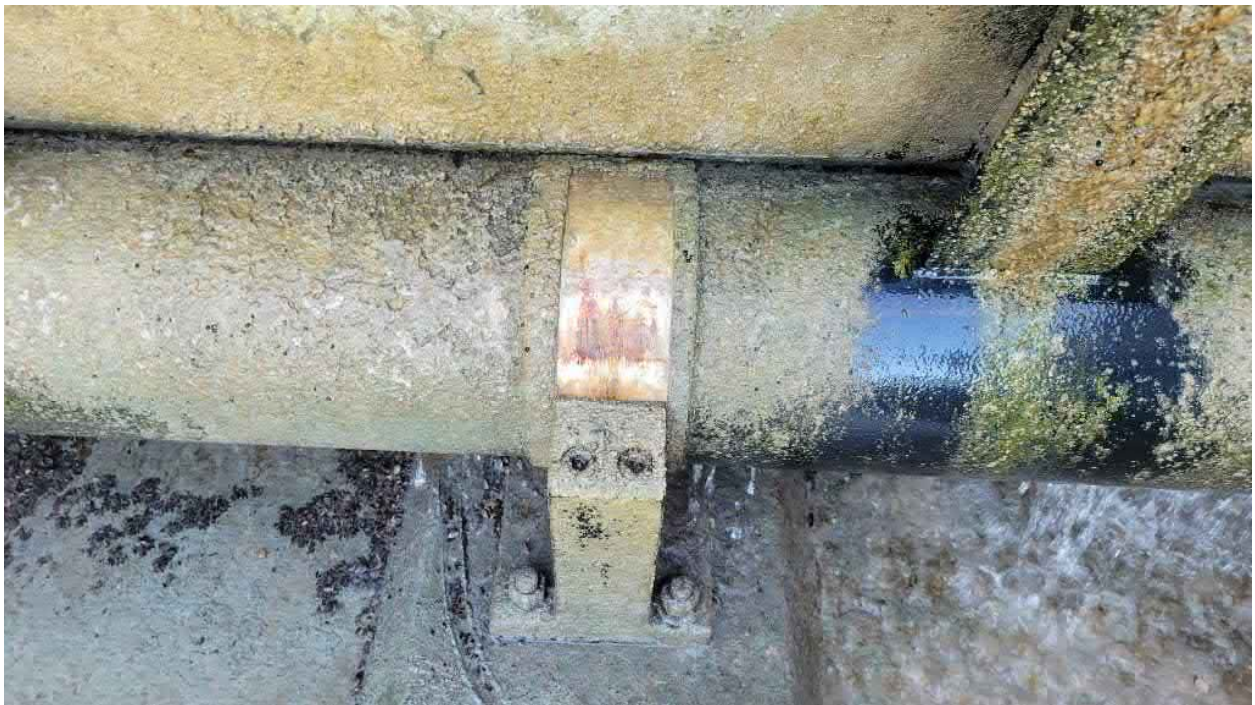
Joint Observation - Corrosion

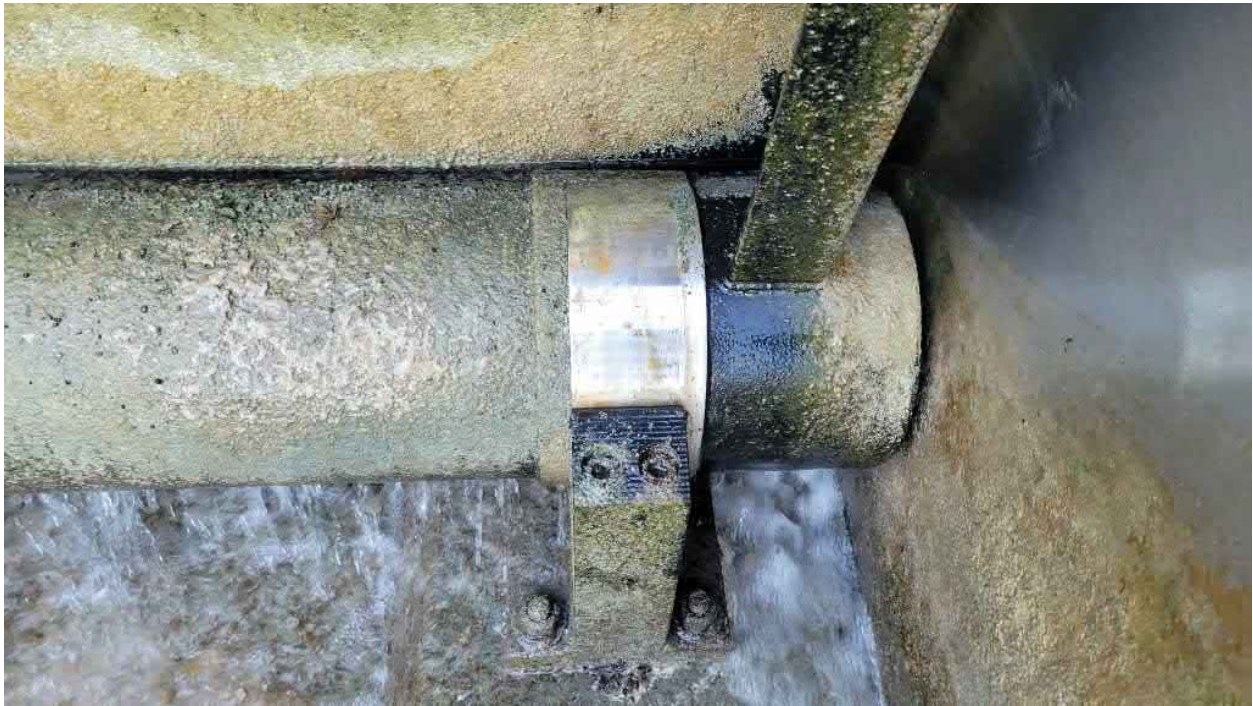
Joint Observation - Corrosion

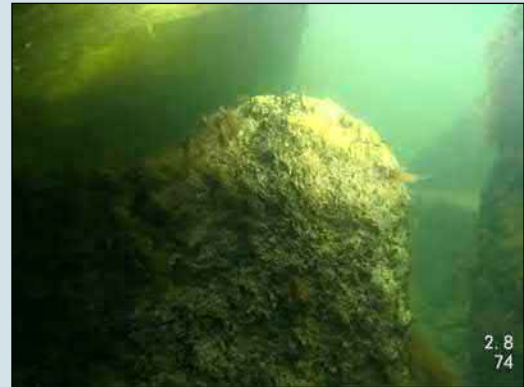
Pier #2 was removed with the rehabilitation project. At the downstream end there is a scour wall directly below where Pier #2 was that intersects the downstream cutoff wall and extended to the end of the spillway. There was an additional scour wall separated by a gap that continued downstream. Both of these scour walls have 1" to 3" deep scale.

Pier #2 scour wall spall.

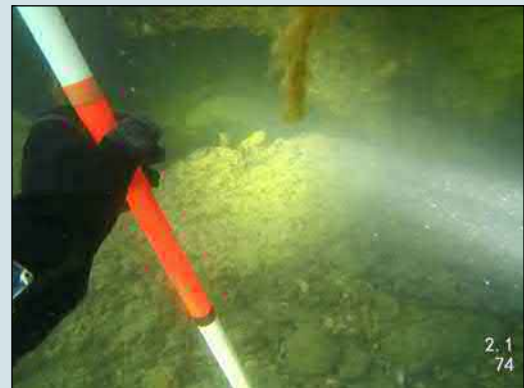
Pier #3 consists of a variable height wall cast on the spillway slab. The wall above the slab has been rehabilitated and is in good condition. The wall serves as the south wall of the machine room. At the downstream end here is a scour wall underwater directly below Pier #3 that intersects the downstream cutoff wall and extends to the end of the spillway. There is an additional scour wall separated by a gap that continues downstream. Both of these scour walls have scale throughout their surface and spalls at the top corners adjacent to the gap between the walls. There is a gap between the slab and the top of the scour wall under the spillway overhang.

Pier #3 downstream end

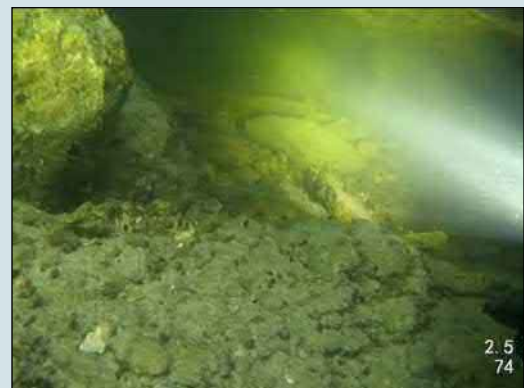
There is a section steel of sheet wall upstream of the right abutment that is in good condition with surface rust above the waterline. It is coated with a chalky sediment up to 1/2" thick. The steel sheeting is in good condition where the sediment was removed.

Cutoff wall and right abutment

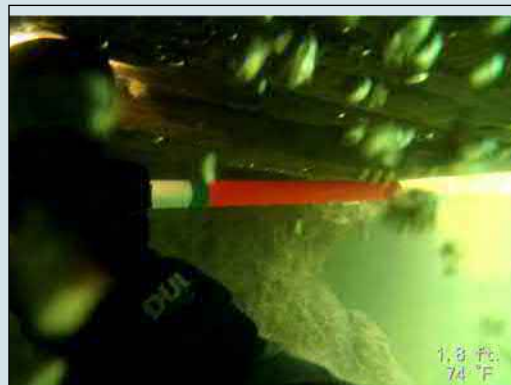
Downstream spillway overhang

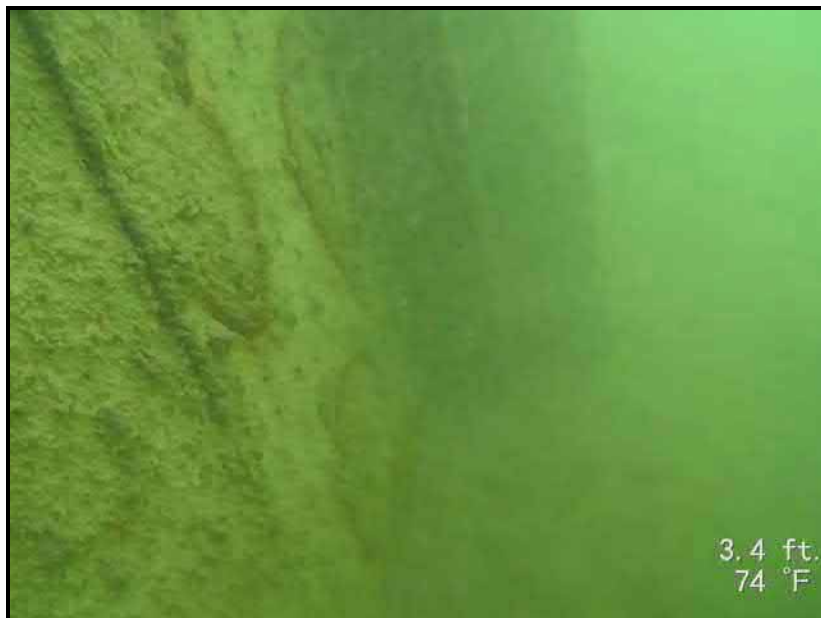
*Upstream steel
cutoff wall
missing sheet*

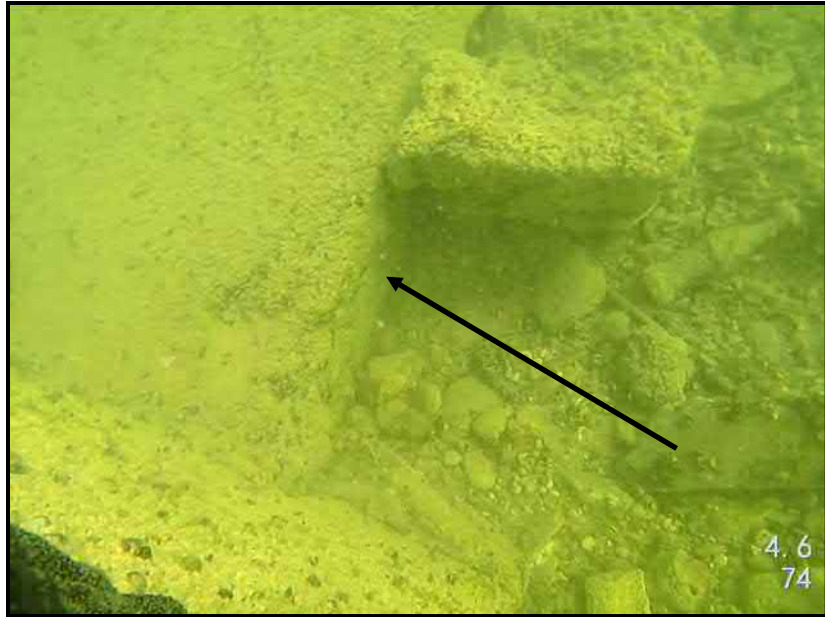
*Upstream steel
cutoff wall*

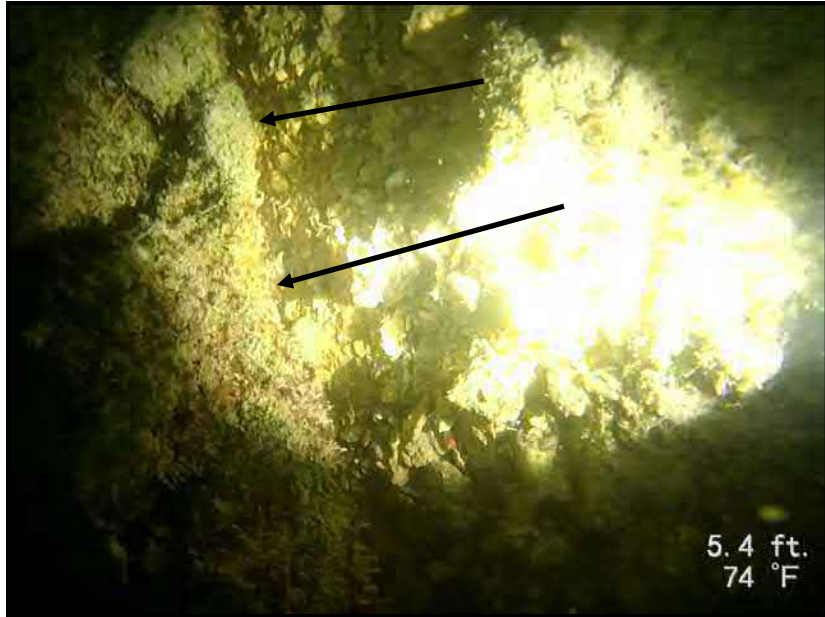
*Downstream
bay 3 missing I
beam*

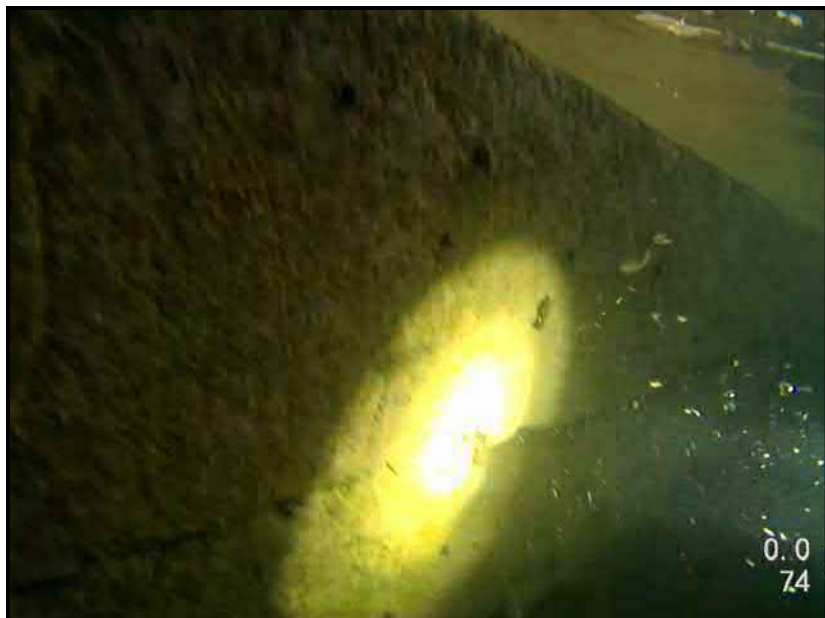
*Downstream
scour wall pier
2*

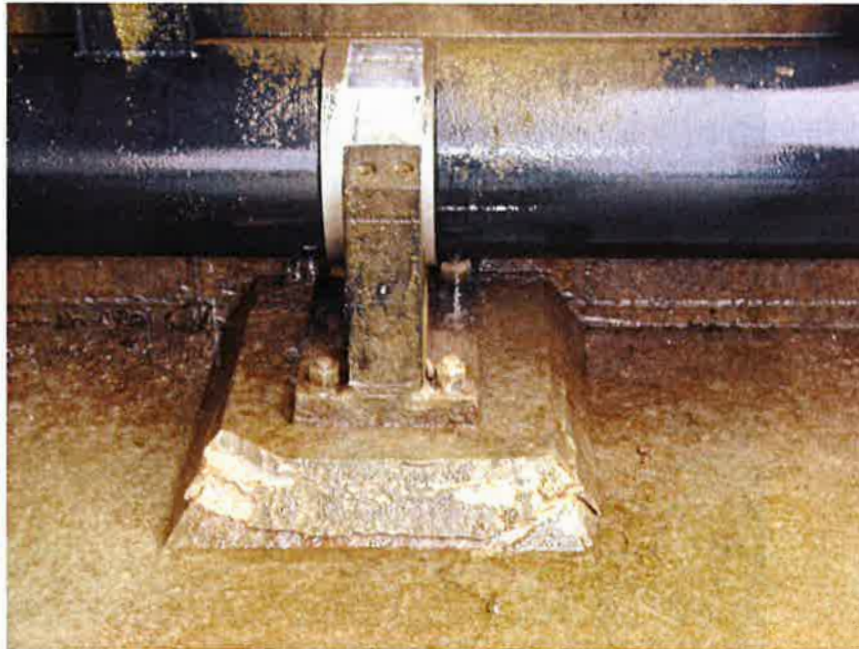
Photo 5. View of spalled grout gate bearing pad.

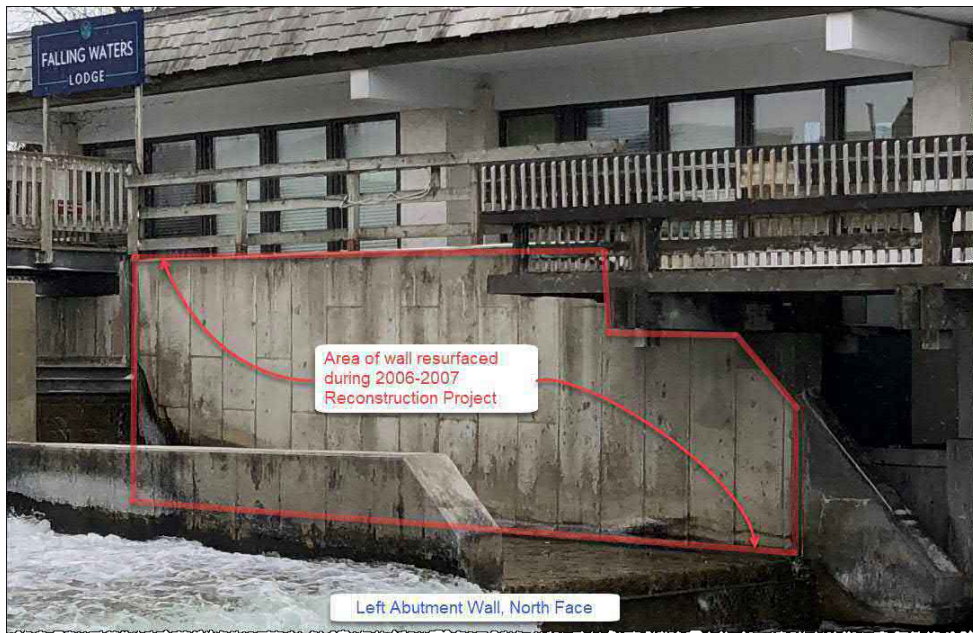
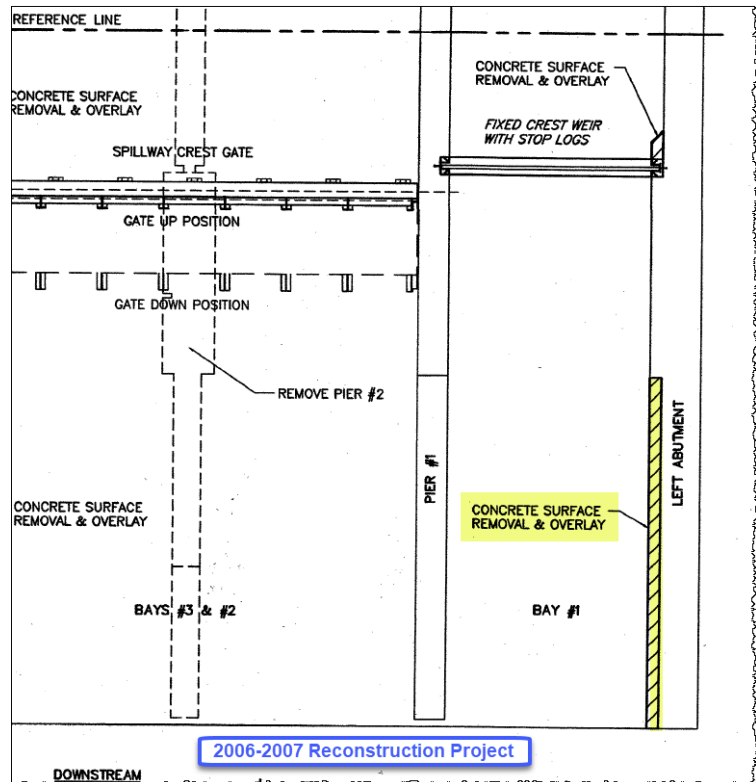
The north face (spillway side) of the wall is in good condition with minor areas of deterioration noted near the end of the spillway. Most of the north face was resurfaced during the rehabilitation project.

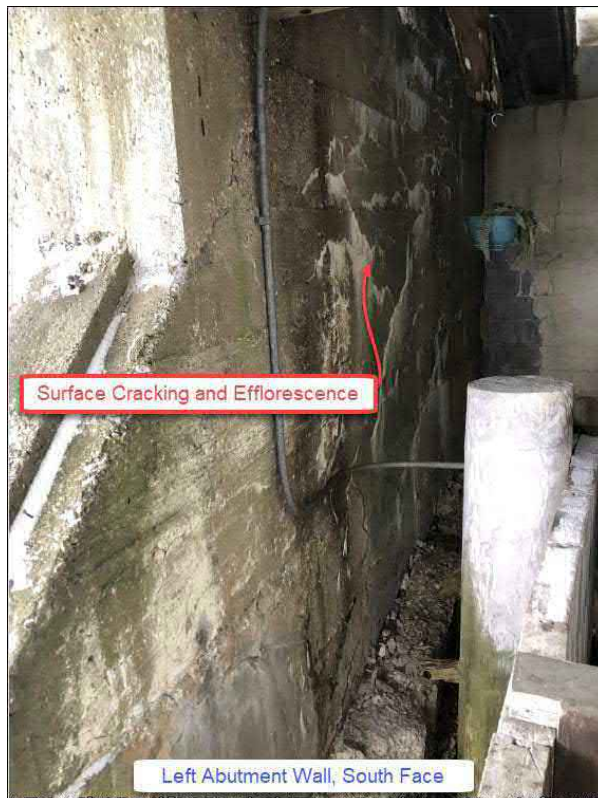
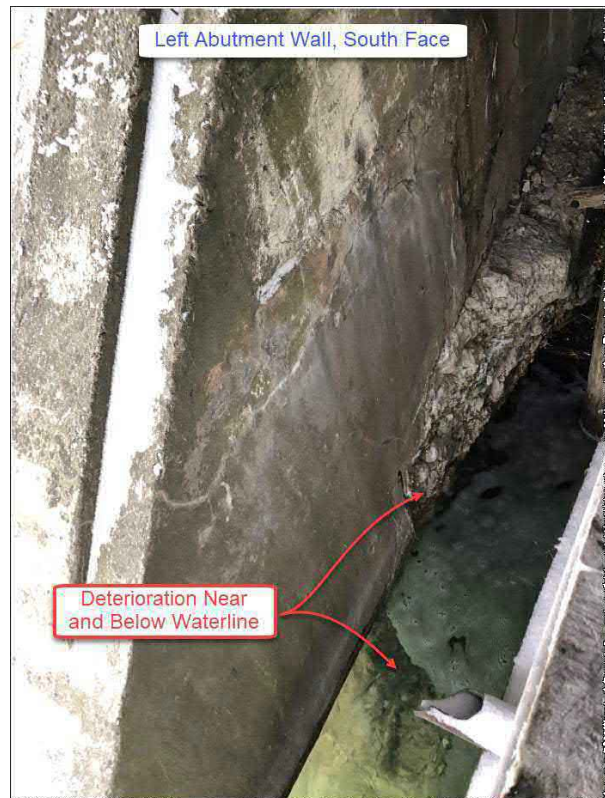
The south face (Lodge Side) of the left abutment exhibited surface cracking and efflorescence. This cracking appeared to be only surface defects and the wall is in sound condition.

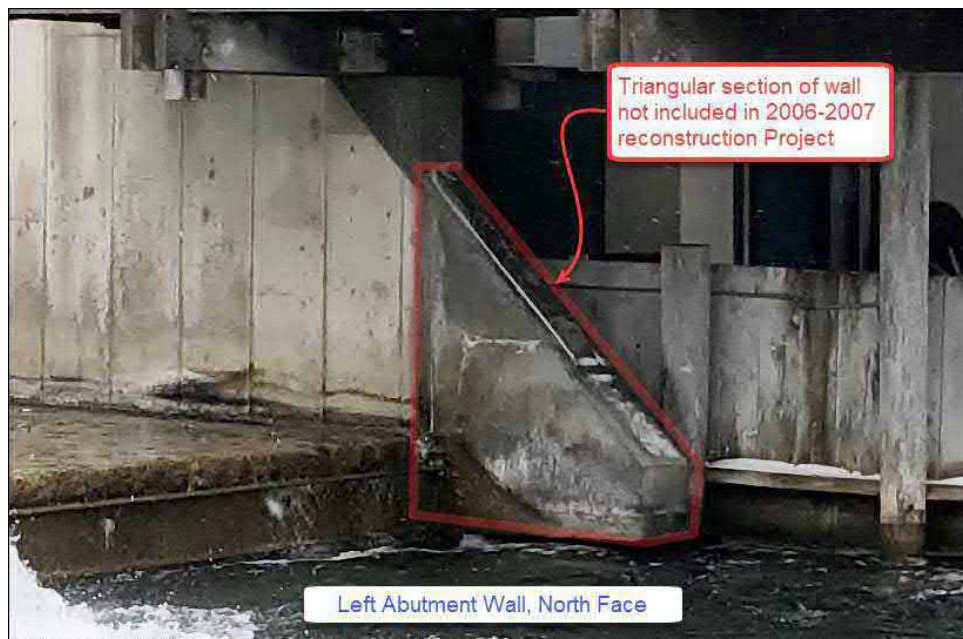
There is a section of the wall that is perched over the downstream end of the spillway. This portion of the wall did not have repairs completed during 2006-2007 rehab project. This portion of the wall appears to be in sound condition with minor cracking on both the north and south faces. There were areas observed near the waterline and below that may exhibit deterioration. This area could not be inspected during this site visit and would require a diver to further investigate the overall condition.

During the meeting anticipated repairs and the methods needed to complete these repairs were discussed. Anticipated repairs included minor concrete surface patching to the south side of the left abutment wall. In addition, there may be repairs required along the downstream side of the spillway near the perched end of the left abutment which may include sheet piling, underpinning, and concrete fill.
