LELAND DAM INSPECTION

Dam Identification No.: 510
Hazard Potential: High
NE Quarter of Section 9, T. 30 N. – R.12 W
Leelanau County, Michigan
Lake Leelanau

Date of Inspection: September 1, 2022
Date of Report: October 2022

Project I.D. Number 131999SG2022

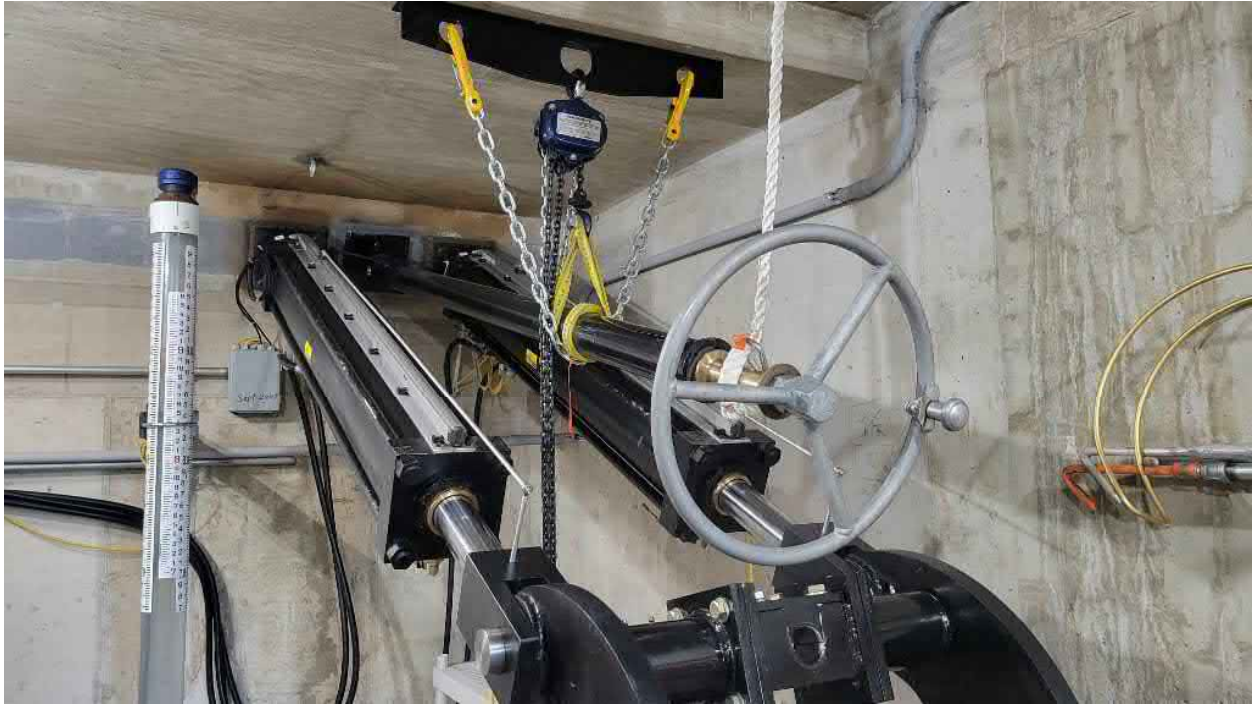
Installed in 2020 - Manual Operator for Hydraulic Lift

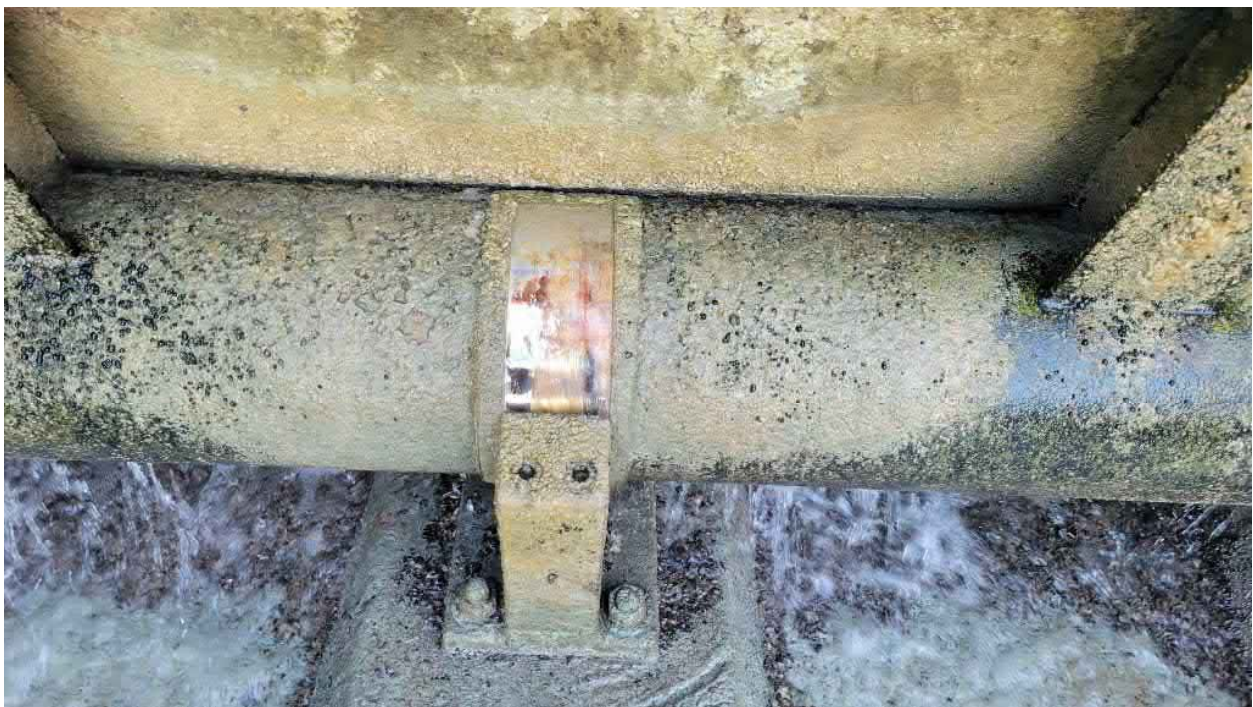
Joint Observation - Corrosion

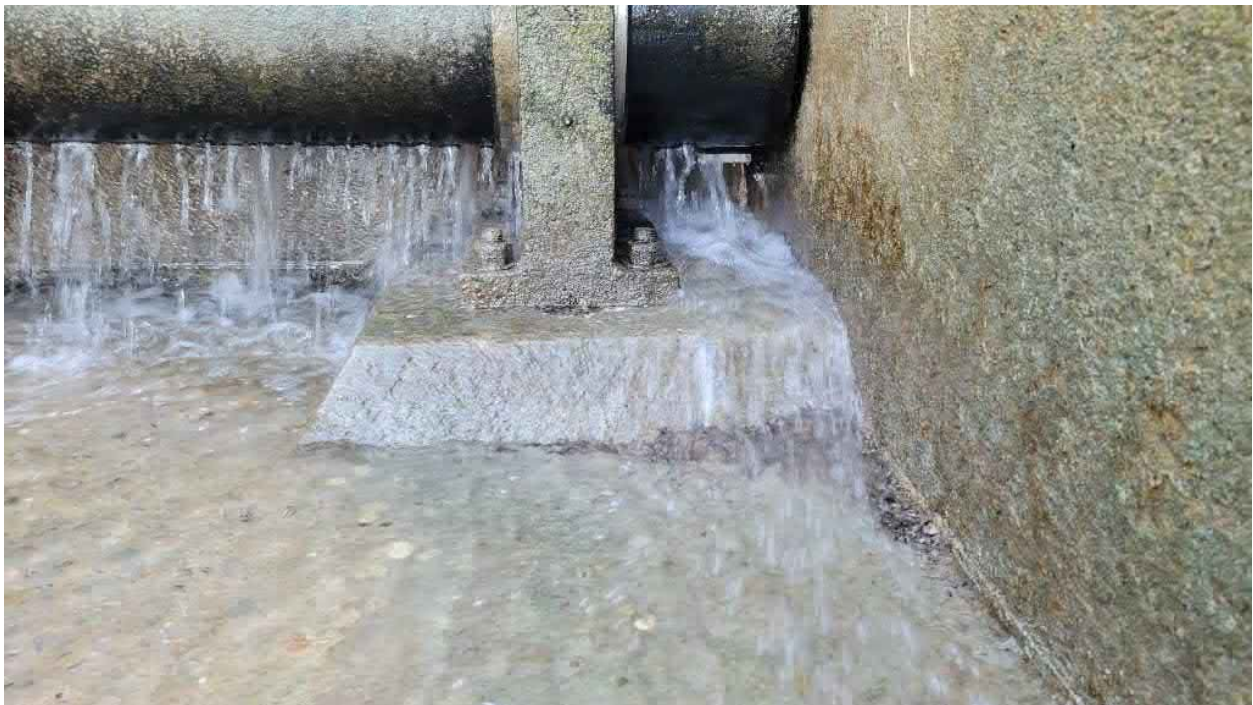
Seepage through Gate While in the Closed Position on the Left Side

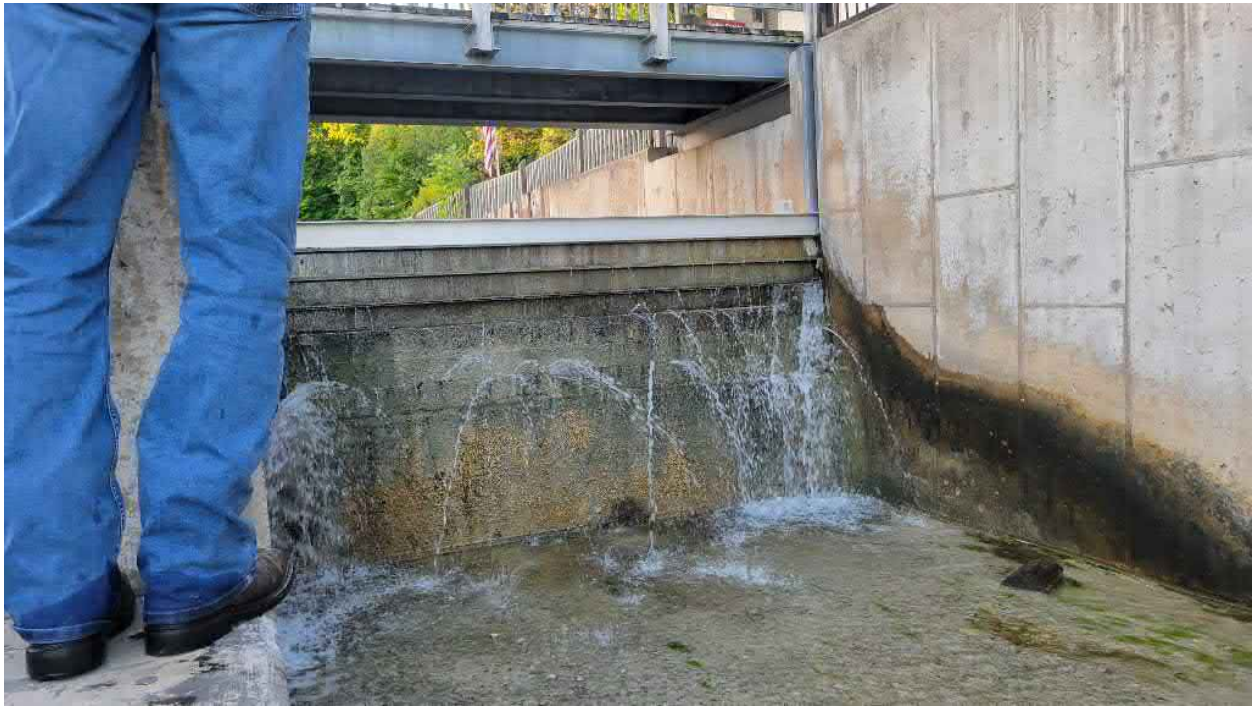
Seepage between Boards of Auxiliary Spillway

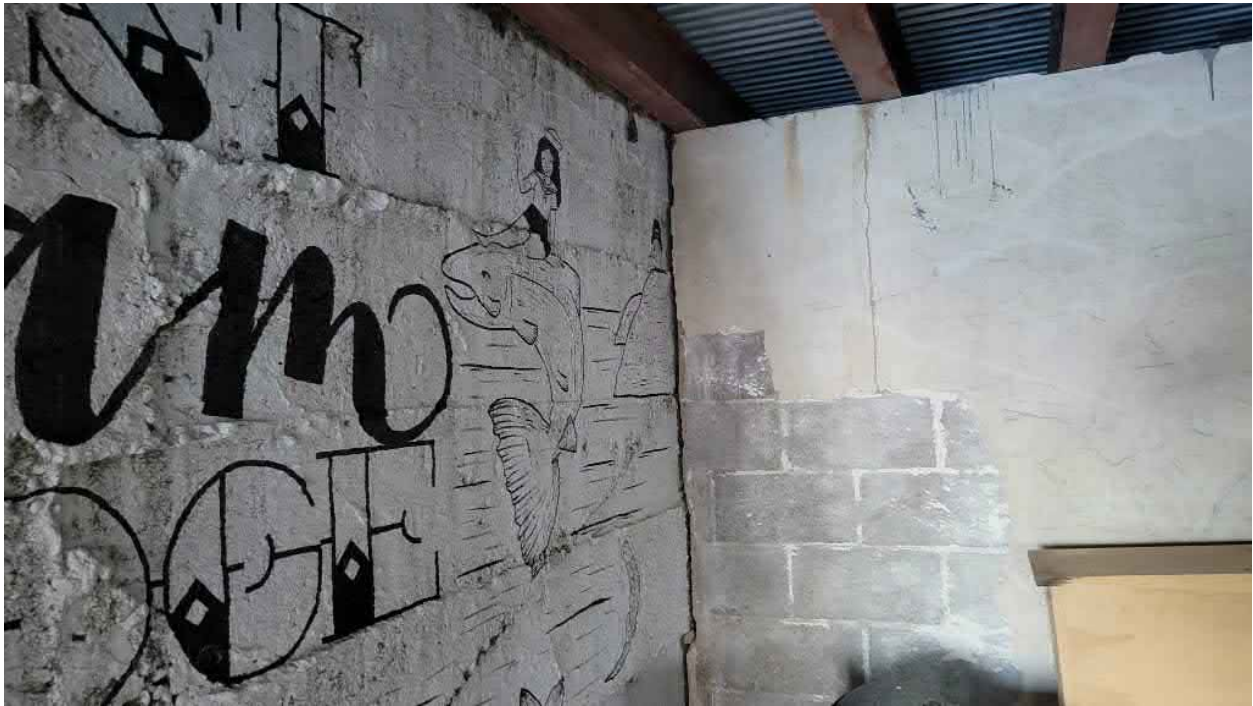
Left Abutment Wall and Wall Adjacent to Dam

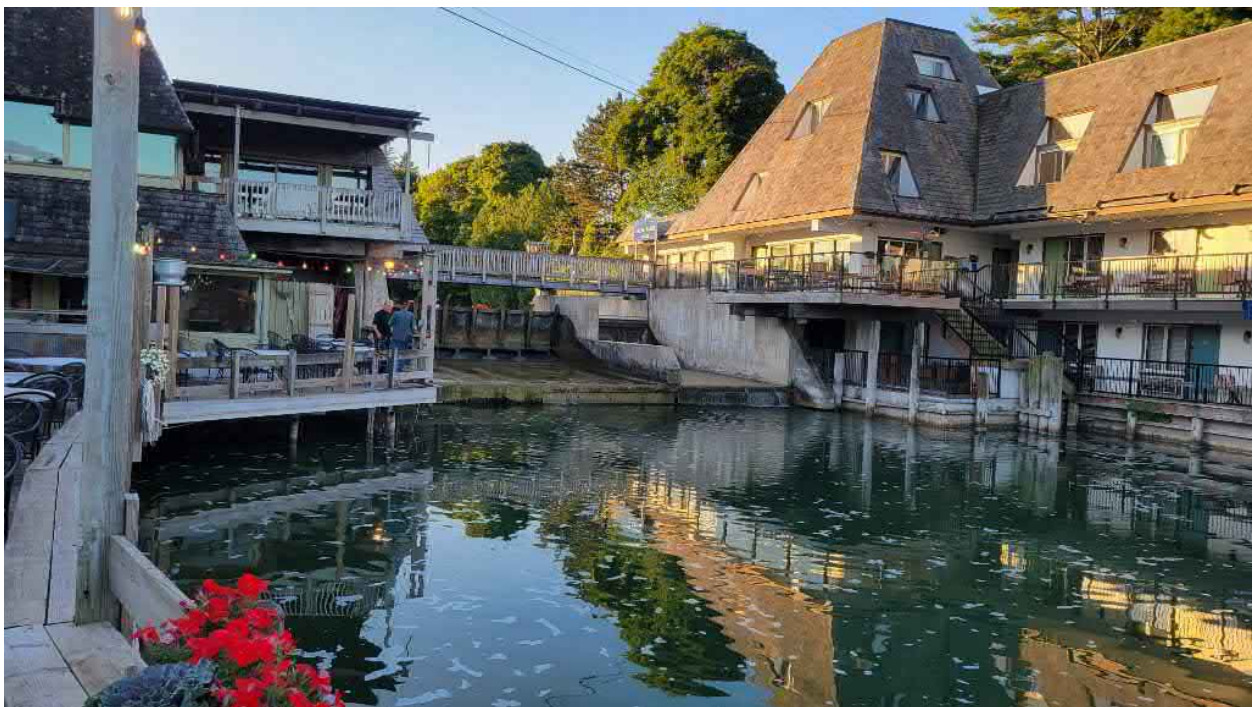
Downstream Face of Dam

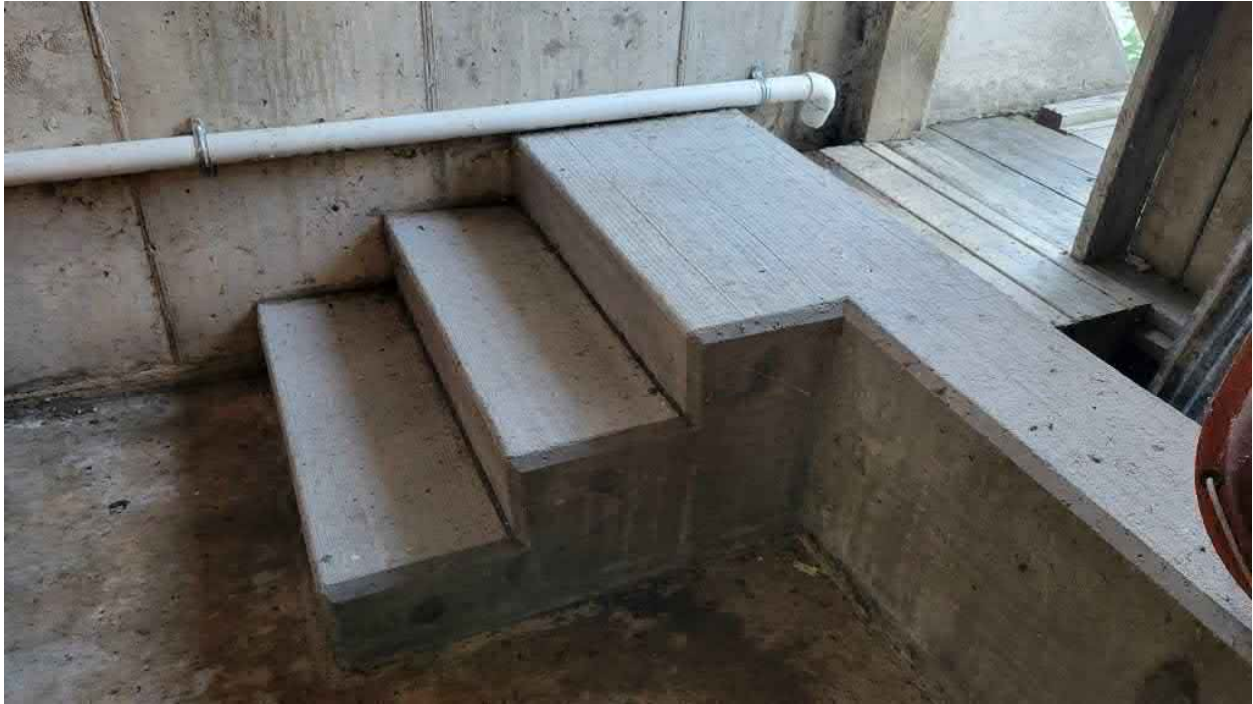
Control Room - Concrete Curb Flood Protection

Recommendation: Install a temporary or permanent means to prevent this backflow, such as removable watertight stoplogs, low floodproofing gates, concrete curb etc. A means to pump out this area will also need to be in place to dewater when the river is too high to allow for draining by gravity.

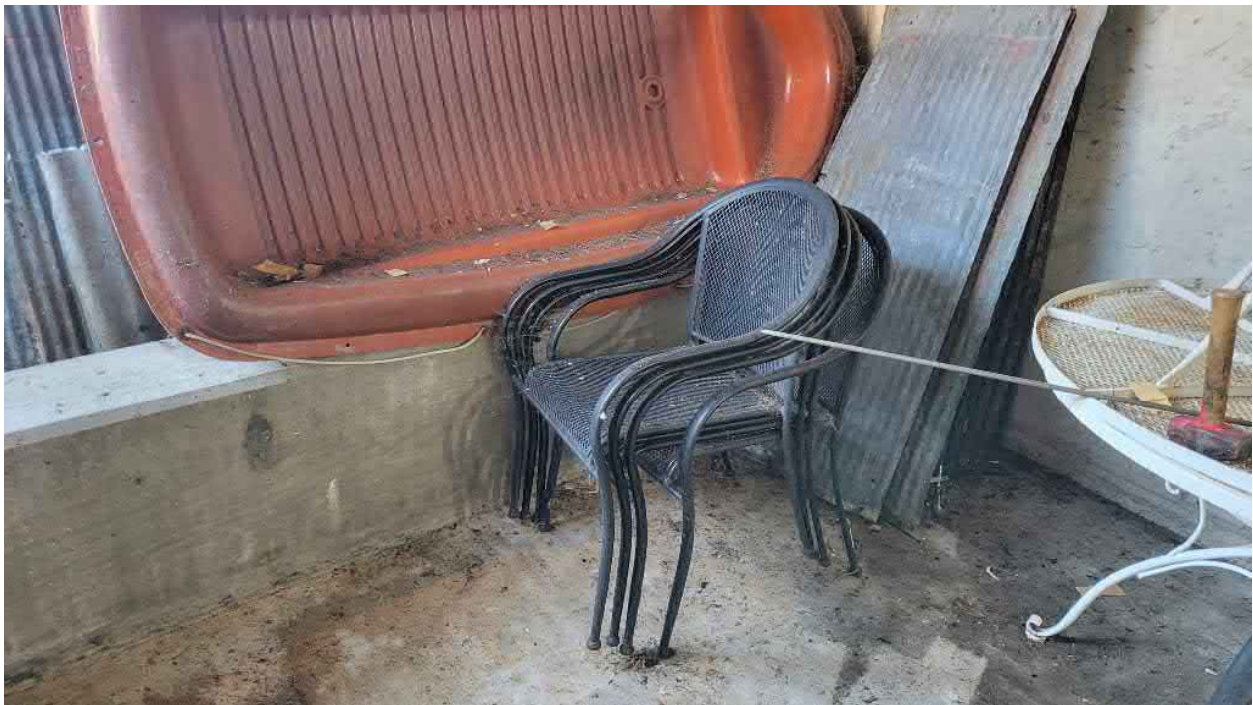
Control Room - Concrete Curb Flood Protection

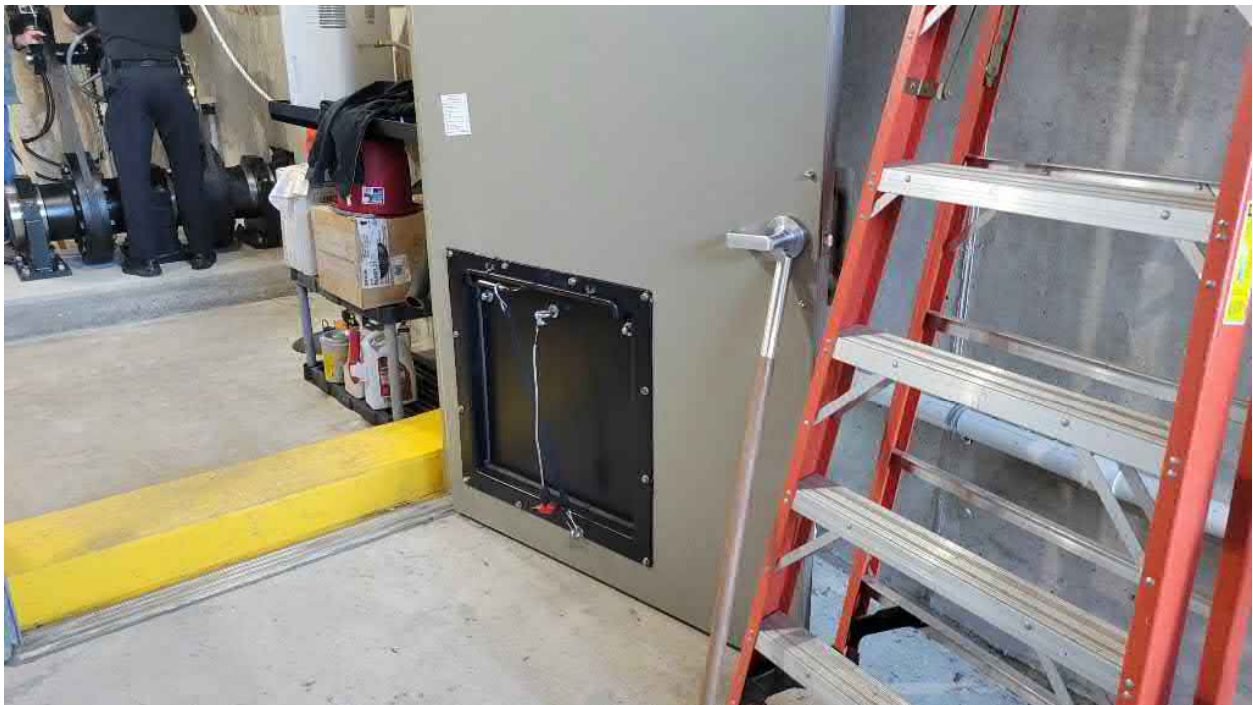
Control Room - Secondary Concrete Curb Flood Protection and Escape Hatch

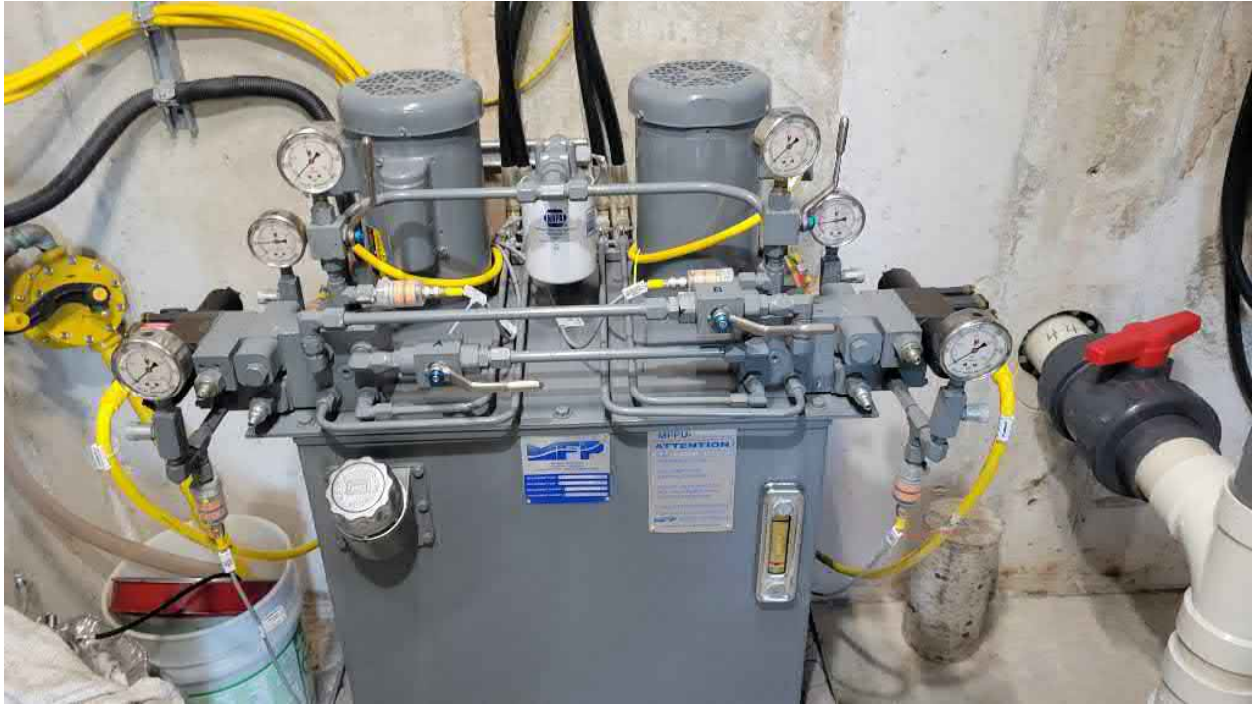
Control Room - Hydraulic Reservoir and Pumps

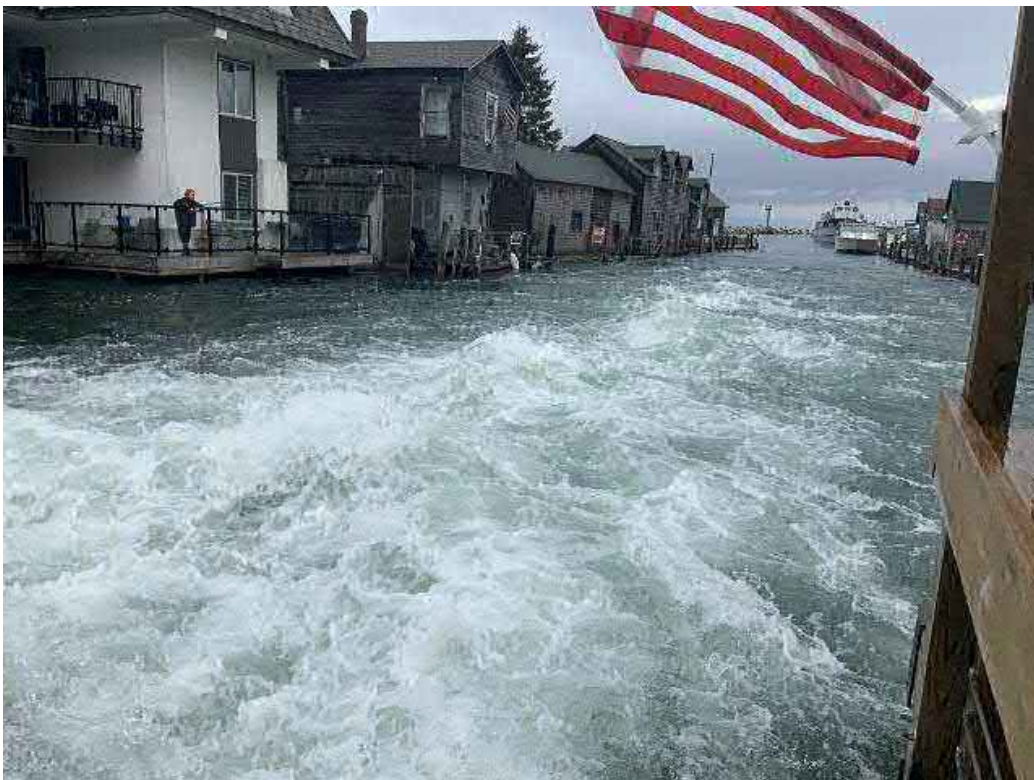
Looking northwest at downstream channel.

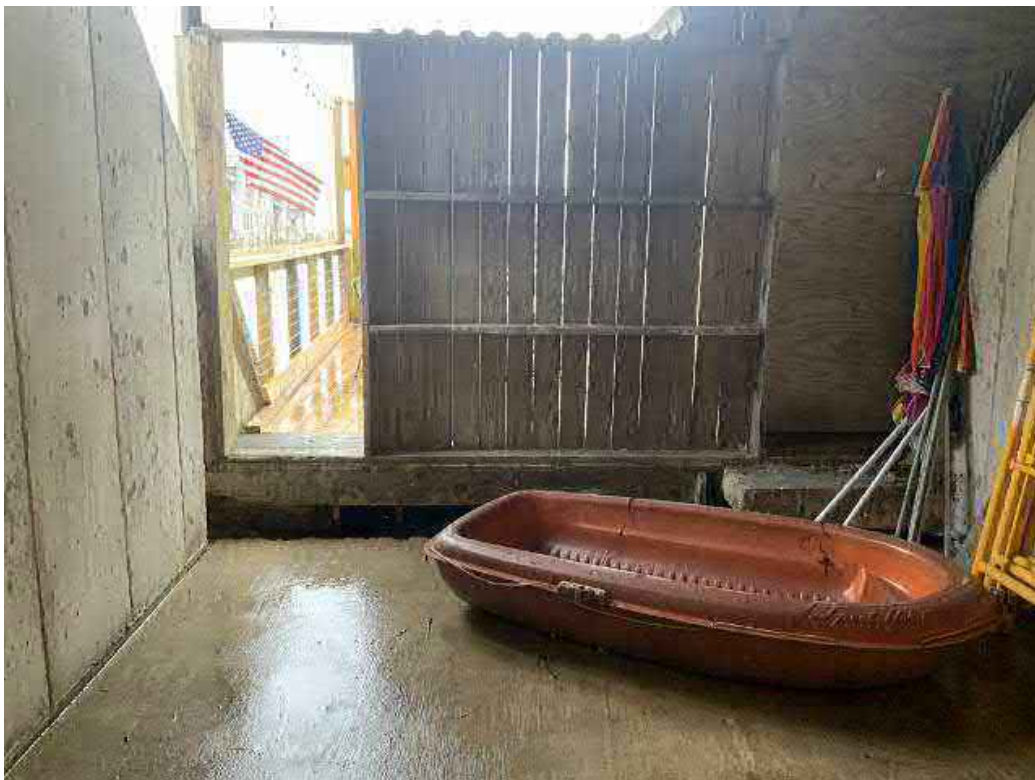
Looking downstream from just downstream of main door into hydraulics / control room.

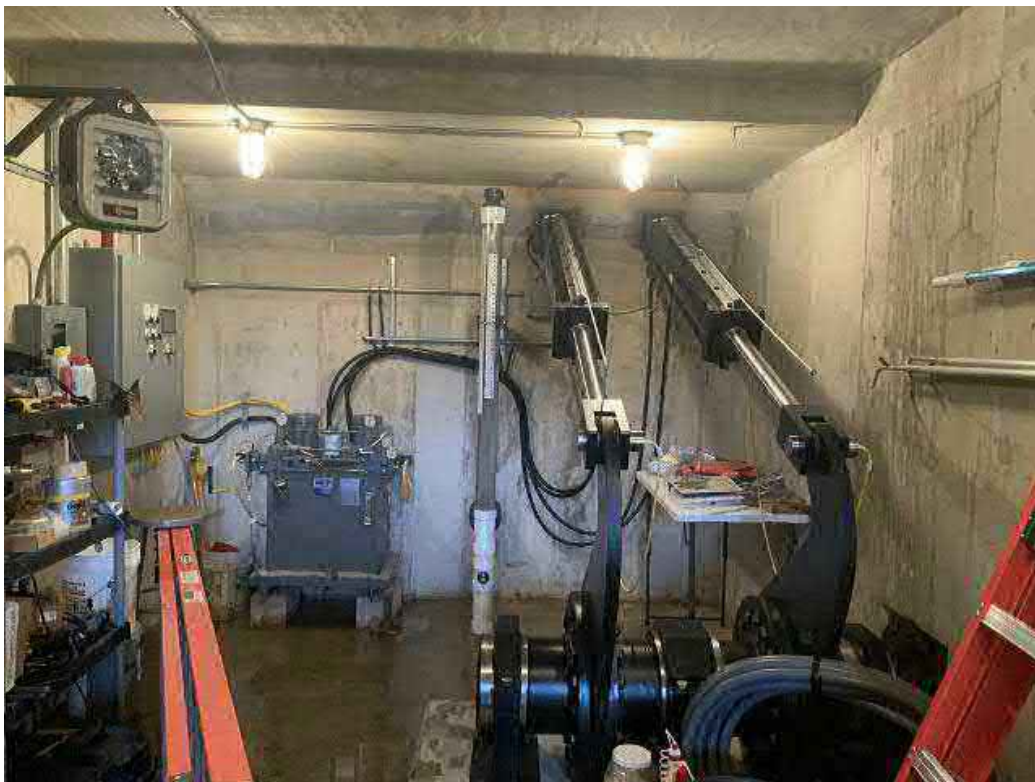
Looking southeast within hydraulics / control room at hydraulic gate actuators.

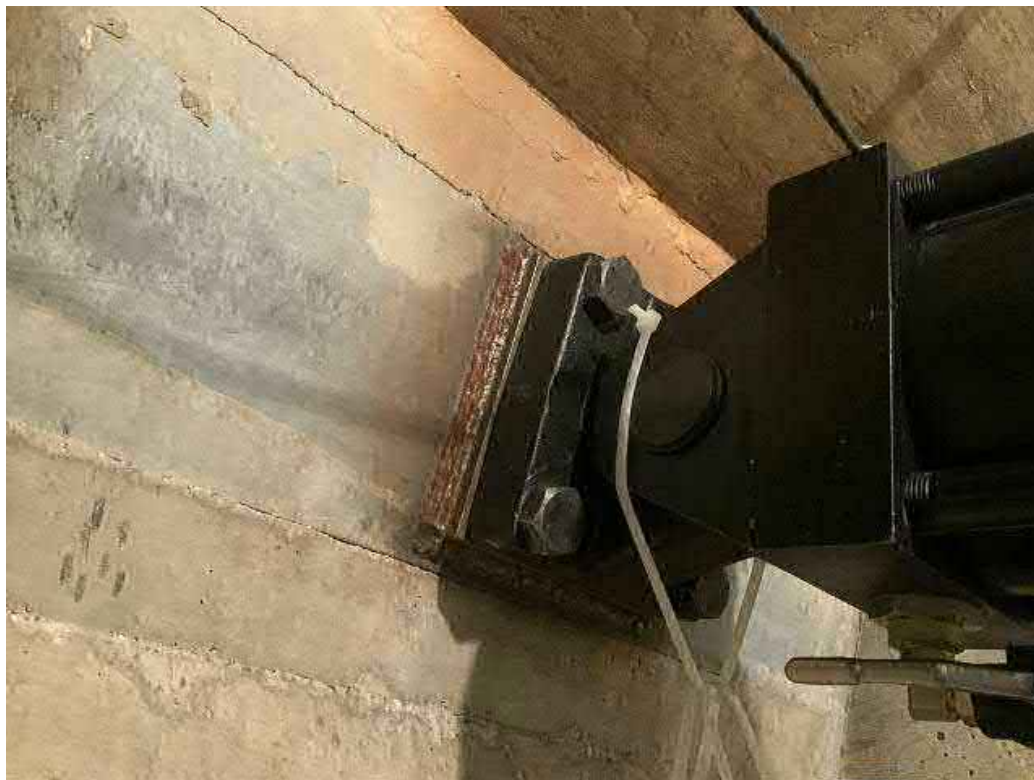
Hydraulic ram mounts to steel I-beam at ceiling / wall corner (typical of 2).

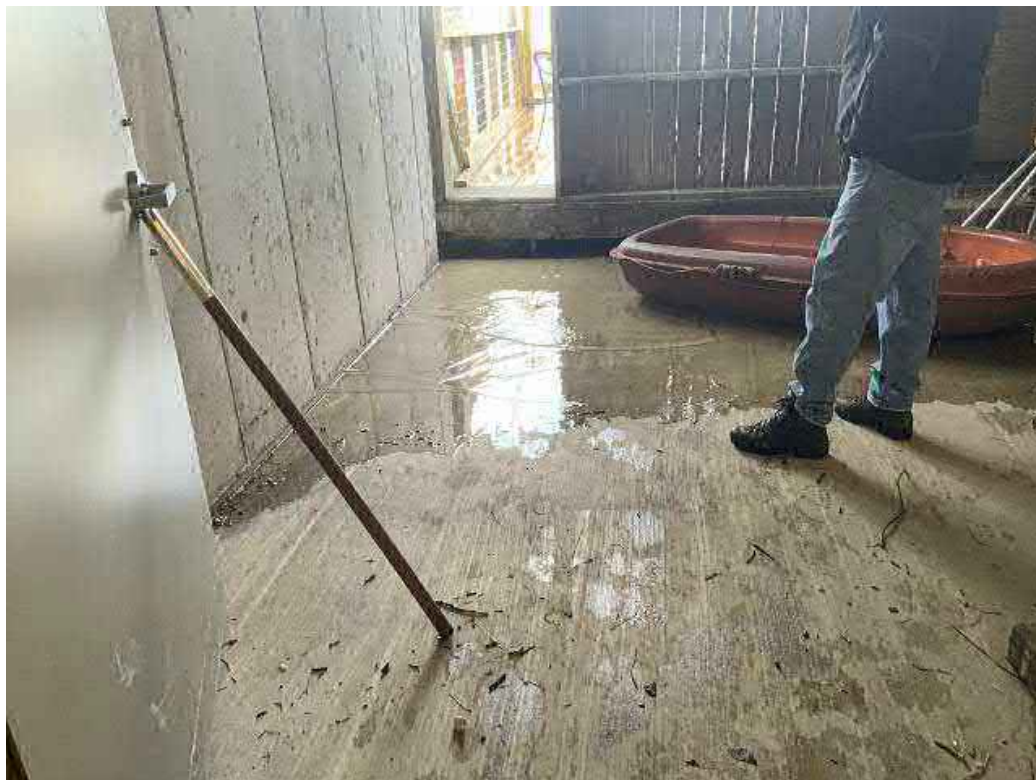
Typical backflooding into Bay #4 downstream of hydraulic / control room due to high Lake Michigan water levels.

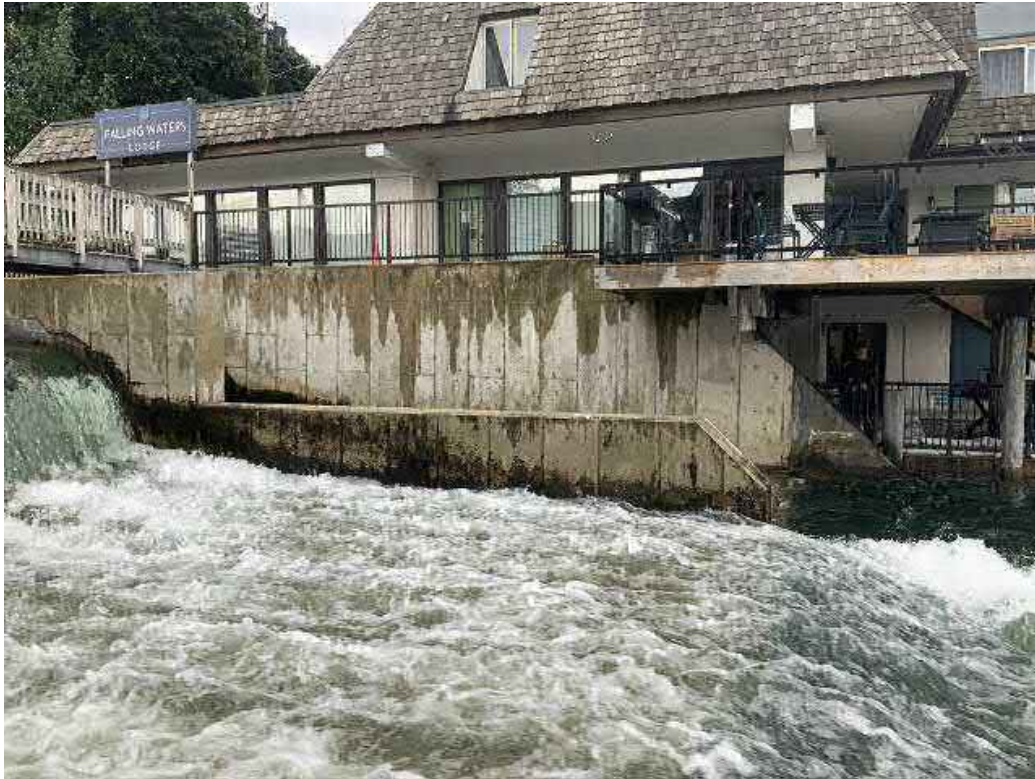
Looking south at principal spillway left abutment wall.

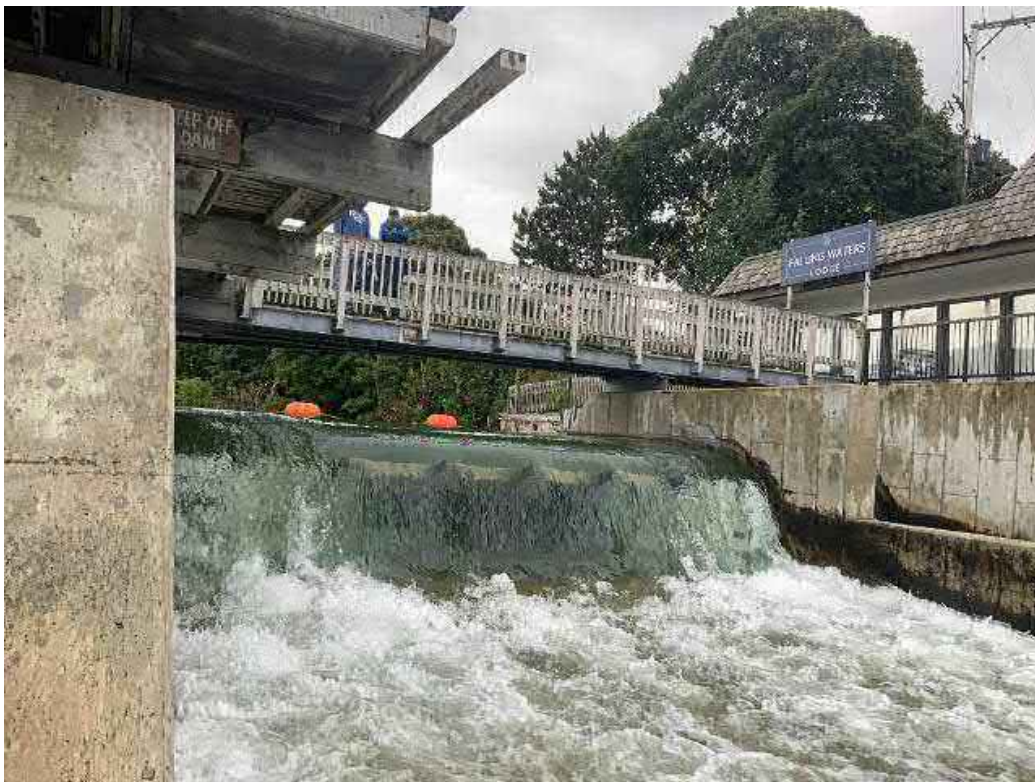
Looking southeast principal spillway (actuated weir gate).

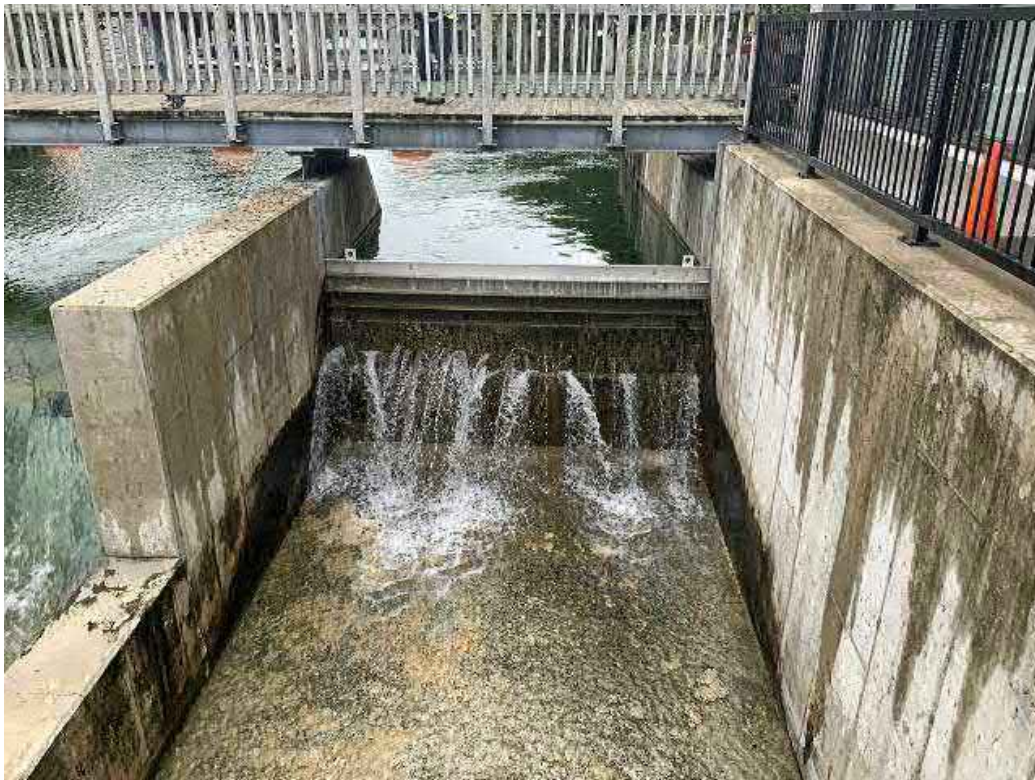
Looking southwast at Bay #1 (fixed concrete crest with removable aluminum stoplogs).

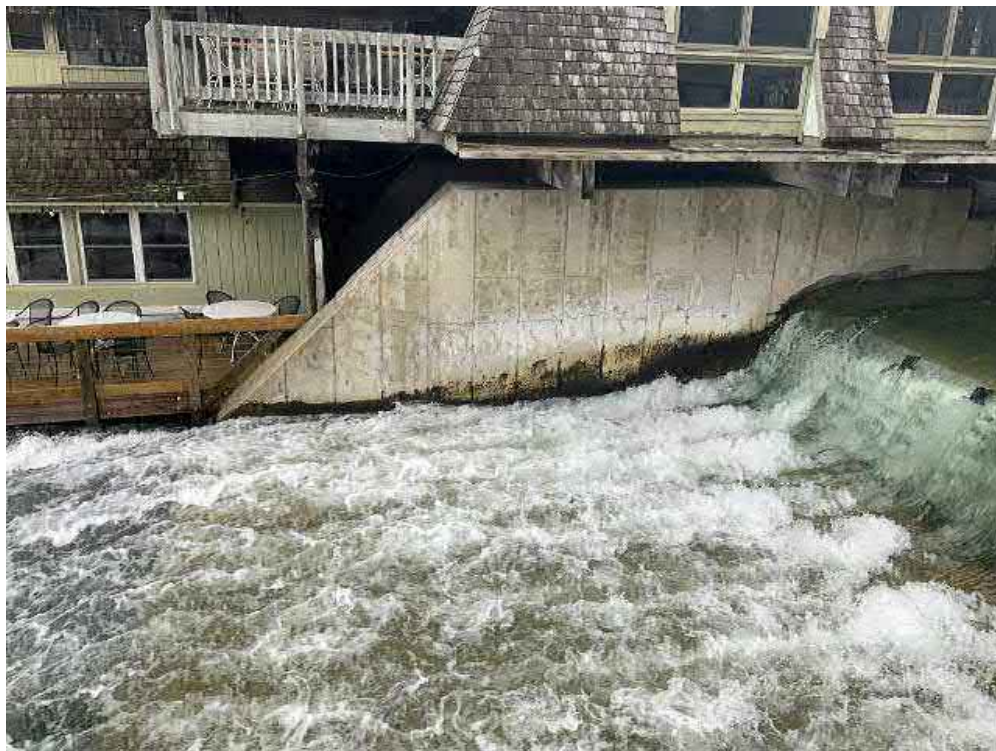
Looking northeast at downstream end of principal spillway and downstream end of right principal spillway abutment wall.

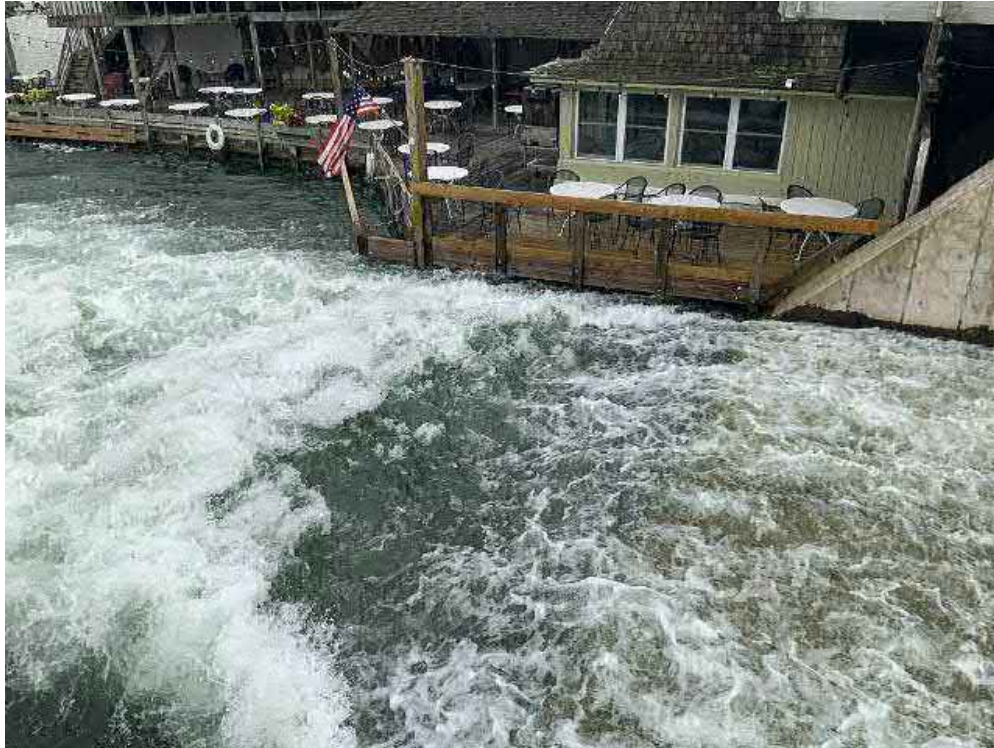
Looking north at downstream end of principal spillway and downstream end of right principal spillway abutment wall.

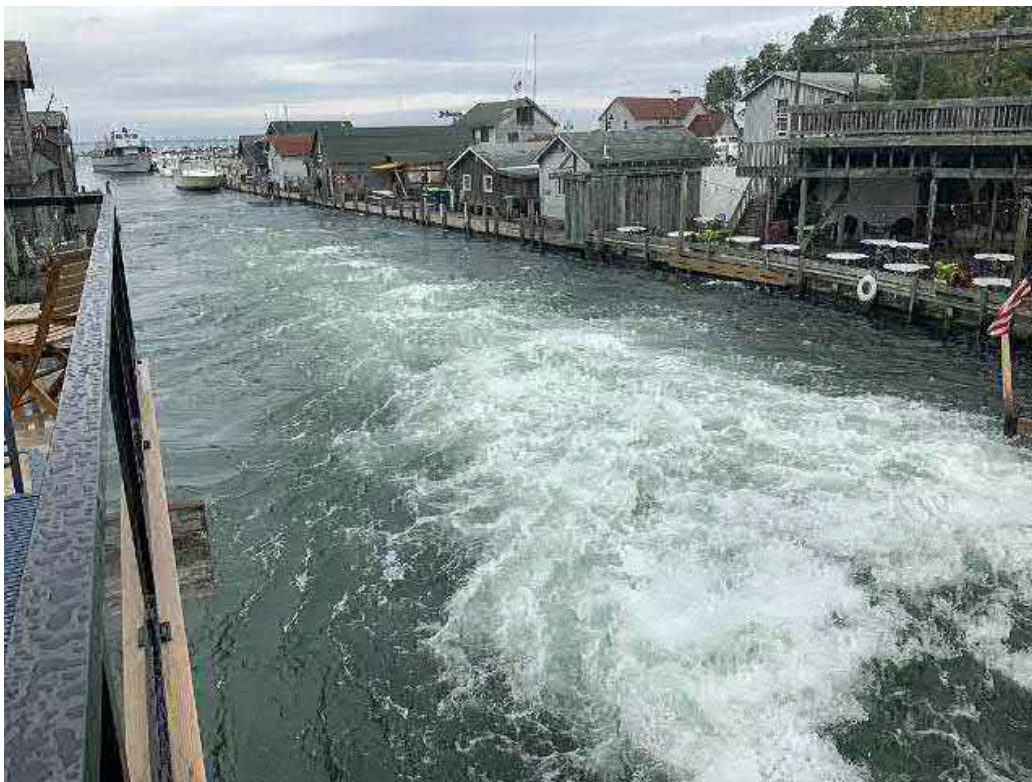
Looking northwest at downstream channel.

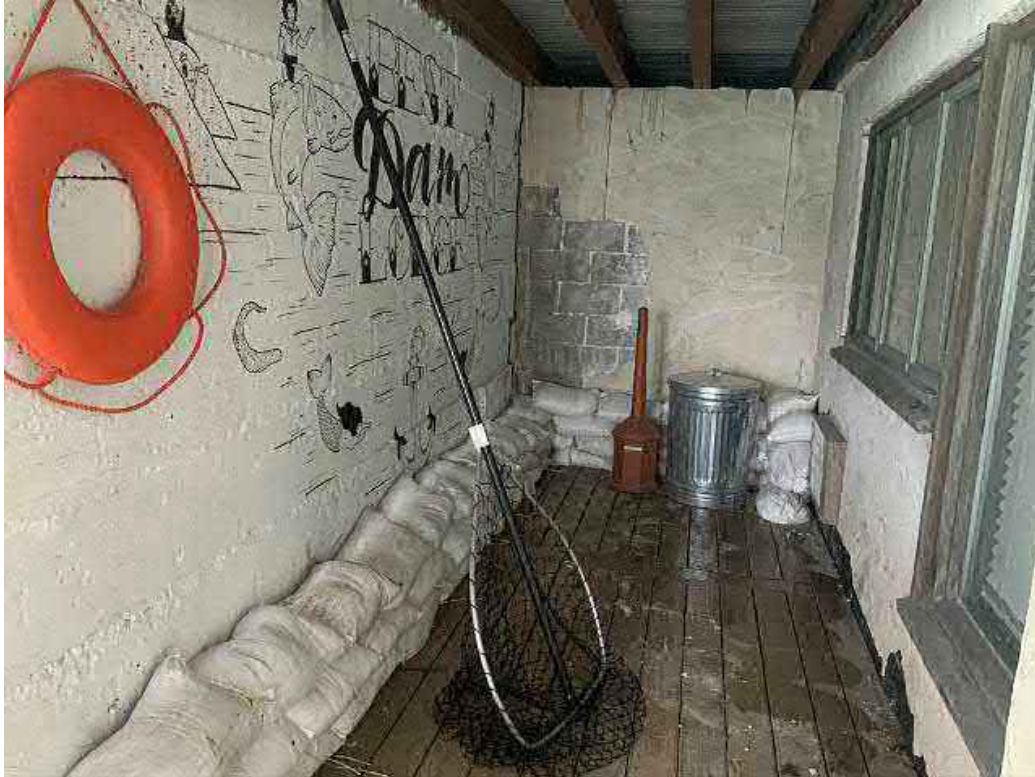
Looking southeast at outside of Bay #1 left abutment wall.

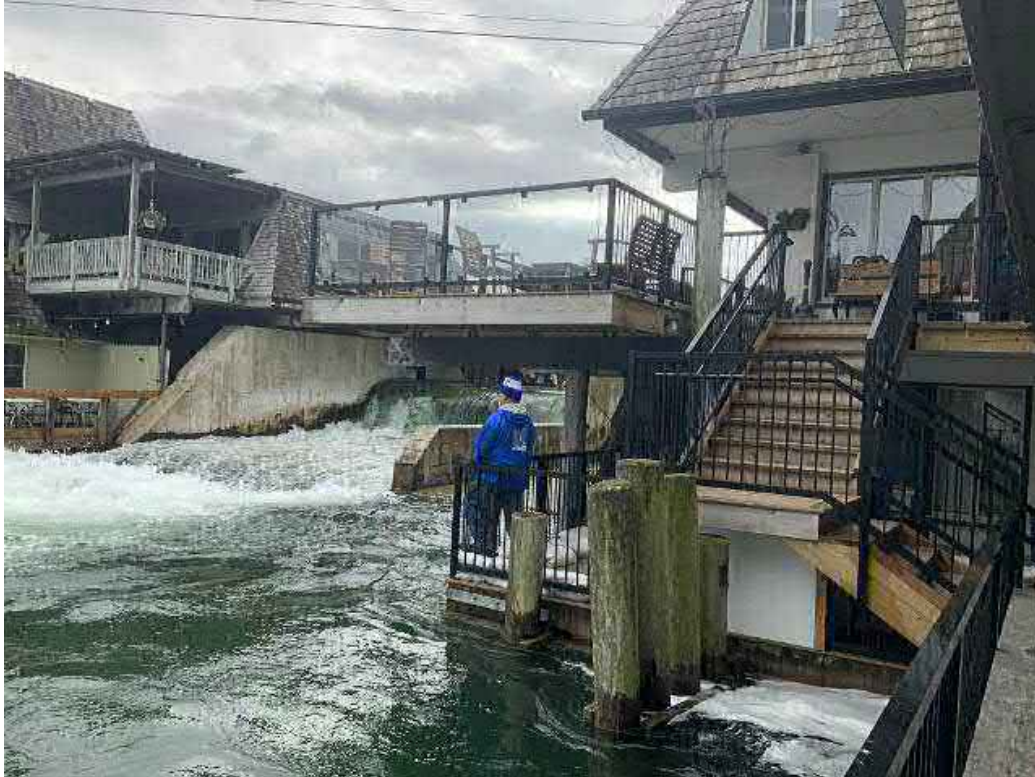
Looking east across at downstream side of dam.

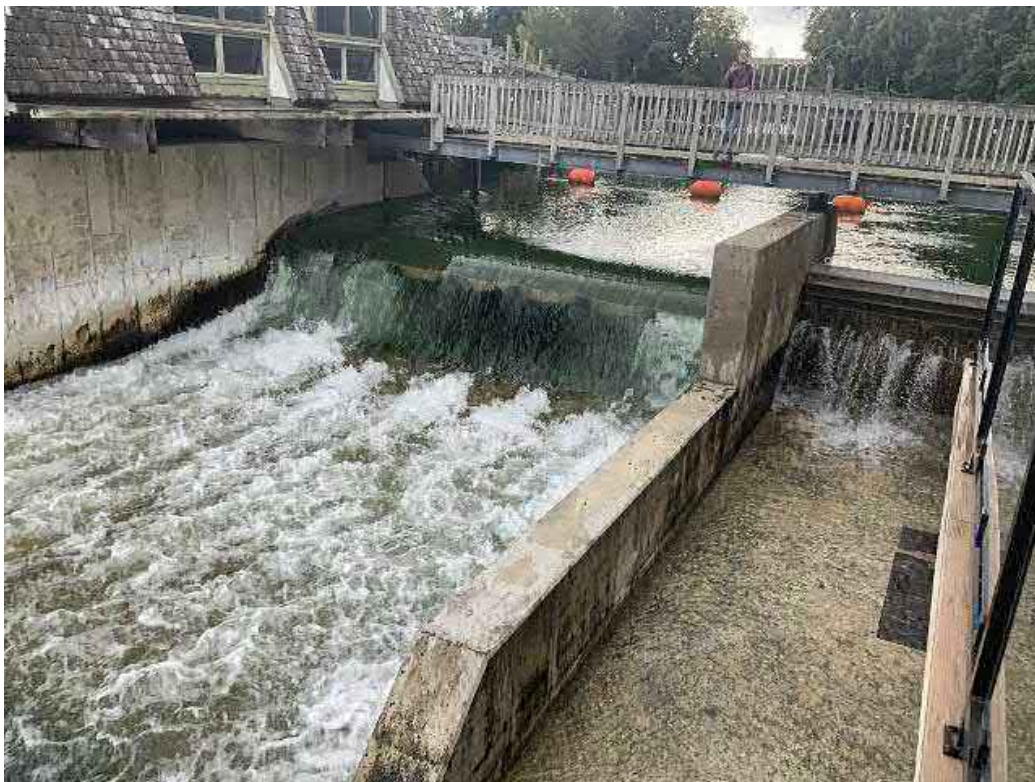
Looking southeast at Principal (former Bay #2 and #3) and fixed crest / stoplog (Bay #1) spillway.

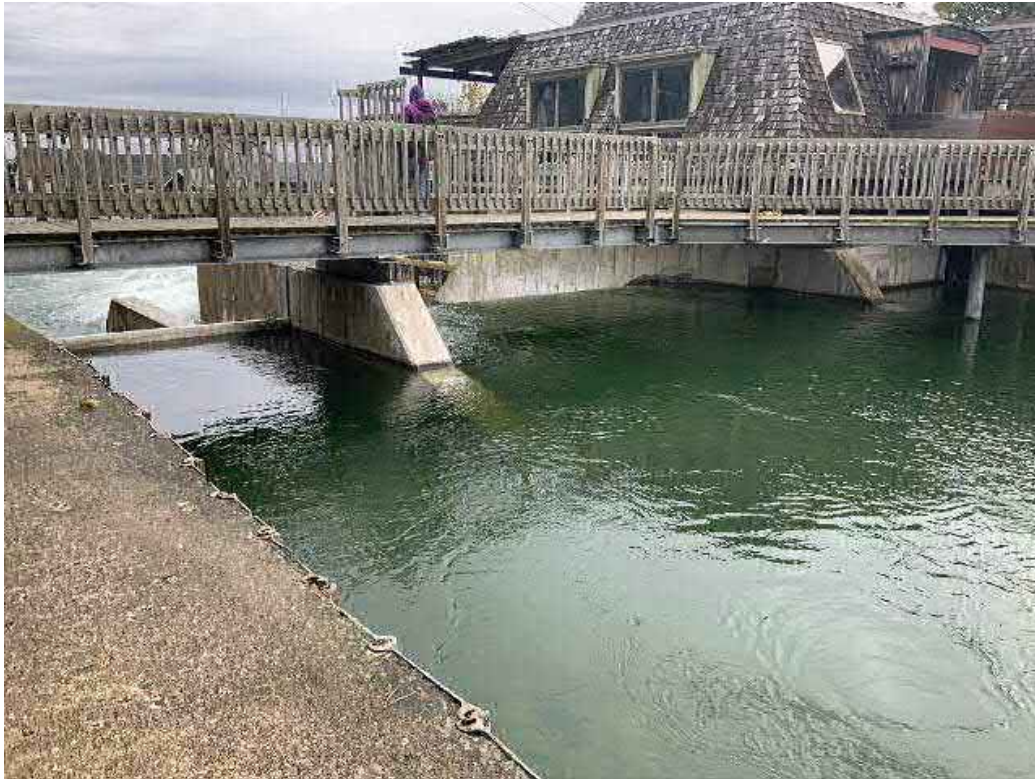
Looking north at walkway and upstream side of dam.

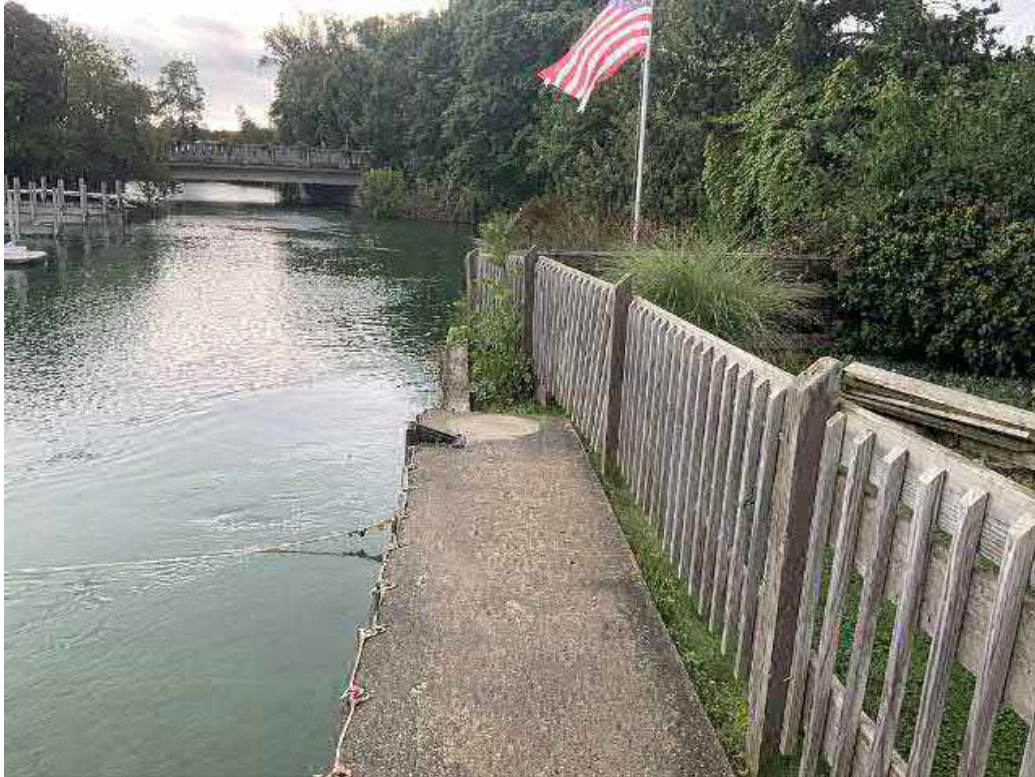
Looking southeast at upper end of left approach abutment wall and wooden seawall.

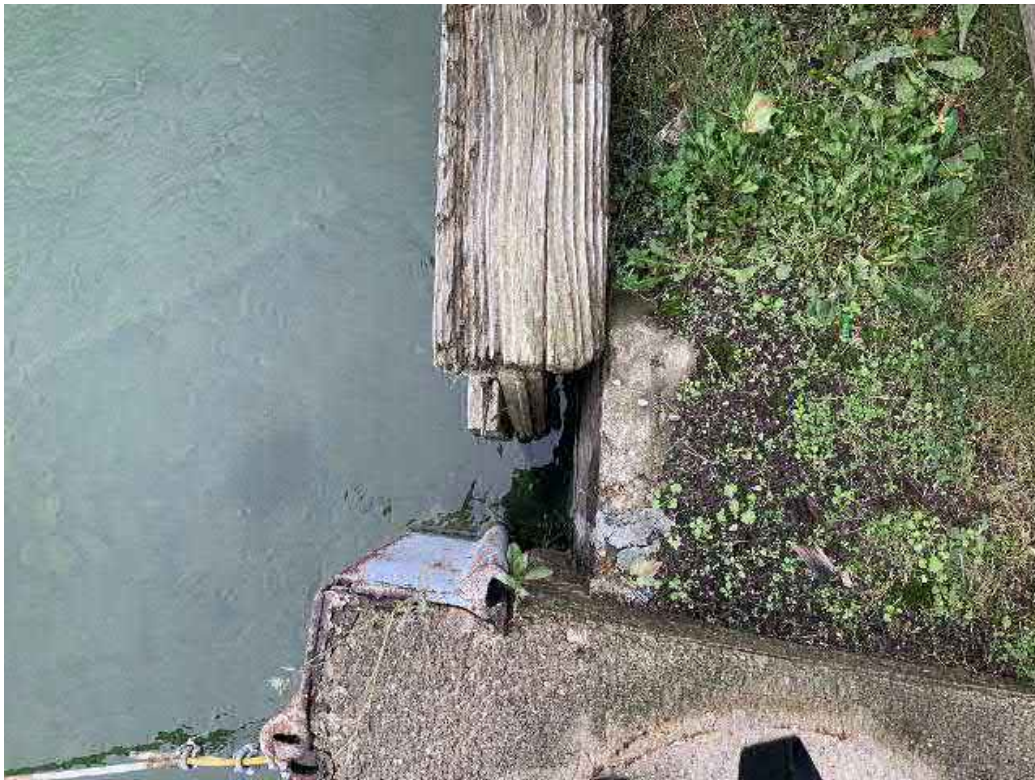
Left approach abutment wall upper end at northwest end of wood seawall.
