LELAND DAM INSPECTION

Dam Identification No.: 510
Hazard Potential: High
NE Quarter of Section 9, T. 30 N. – R.12 W
Leelanau County, Michigan
Lake Leelanau

Date of Inspection: September 1, 2022
Date of Report: October 2022

Project I.D. Number 131999SG2022

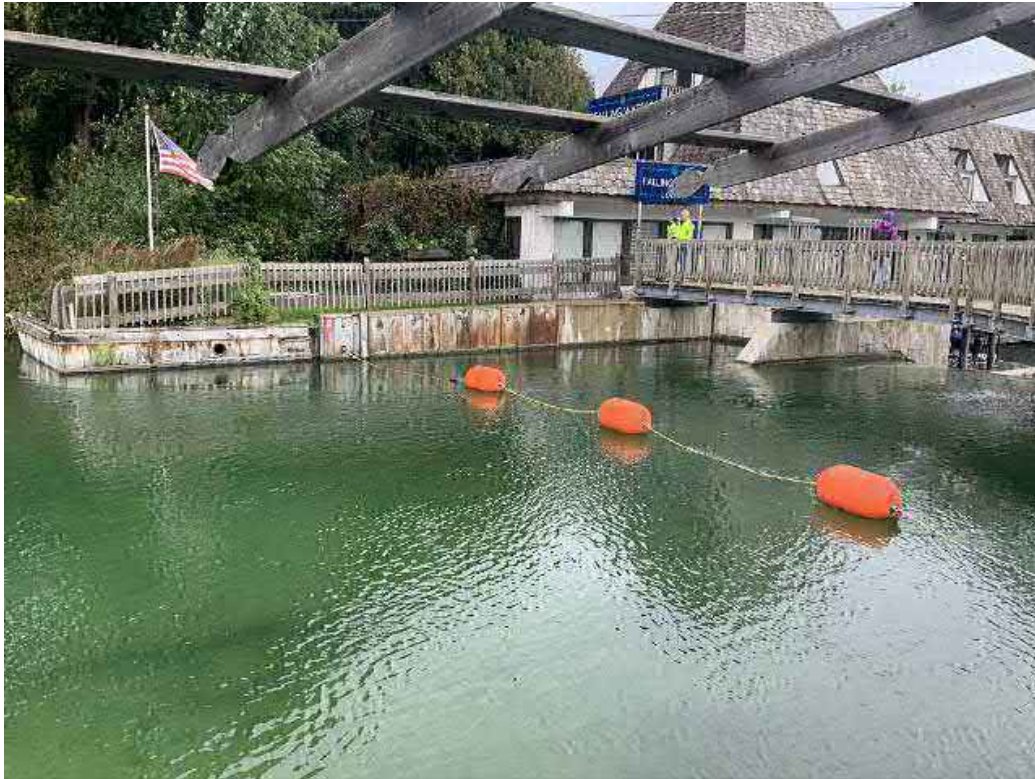
Looking southwest across upstream face of dam at left upstream abutment wall and wooden seawall fence.

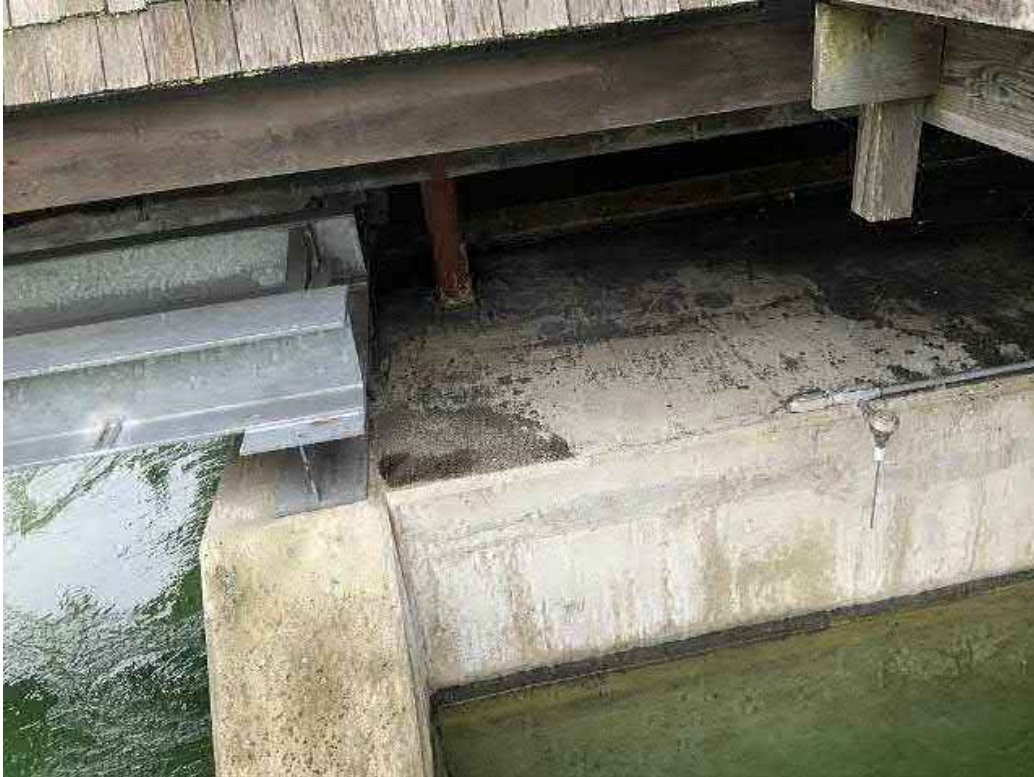
Upstream face of concrete wall and roof at hydraulic / control room (former Bay #4) Walkway steel I-beam supports.

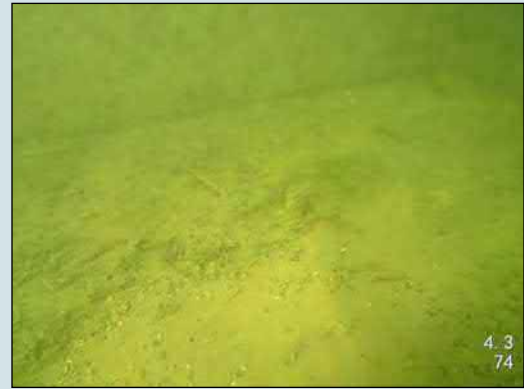
Left abutment and spillway (upstream end)

The left abutments consist of a solid abutment wall founded on a concrete slab footing. The portion above the spillways has been rehabilitated and in good condition. The portion under the downstream spillway, downstream of the cutoff wall, has deep spall with exposed rebar.

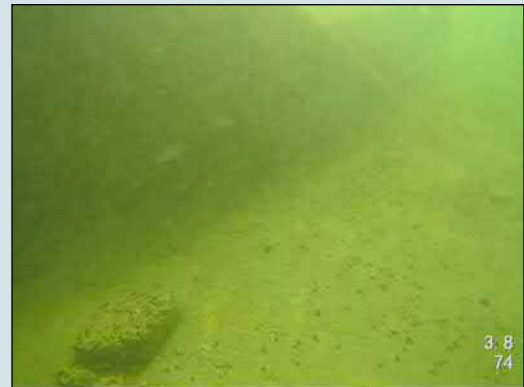
Pier #1 (upstream end)

Pier #1 consists of a variable height wall cast on the spillway slab. The wall above the slab has been rehabilitated and is in good condition. At the downstream end, there were scour walls, similar to the other piers, directly below the pier that is no longer in place. The scour walls have either tipped over, or been removed and utilized as riprap along with other portions of the dam that were removed with a previ-

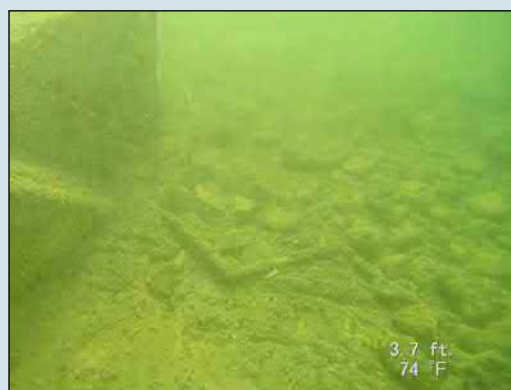
Upstream spillway and steel sheeting

The upstream spillway is a concrete slab with a concrete cutoff wall below the slab. Steel sheeting was left in place at the face of the spillway during the recent rehabilitation project. There is grout between the spillway and the sheeting most of the length. There is a gap in the grout at the original Bay 2 and there is one sheet that is either cut off well below the spillway or was removed. The upstream spillway is partially covered with sediment and in good condition with no undermining.

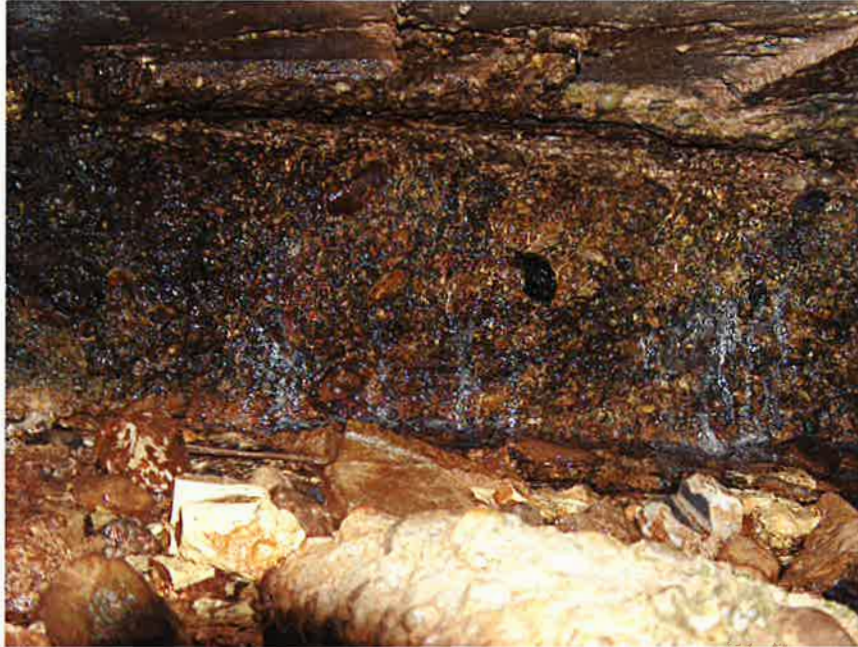
Photo 7. View of seepage flow from under DS right (south) side of spillway slab, 2003 photo.

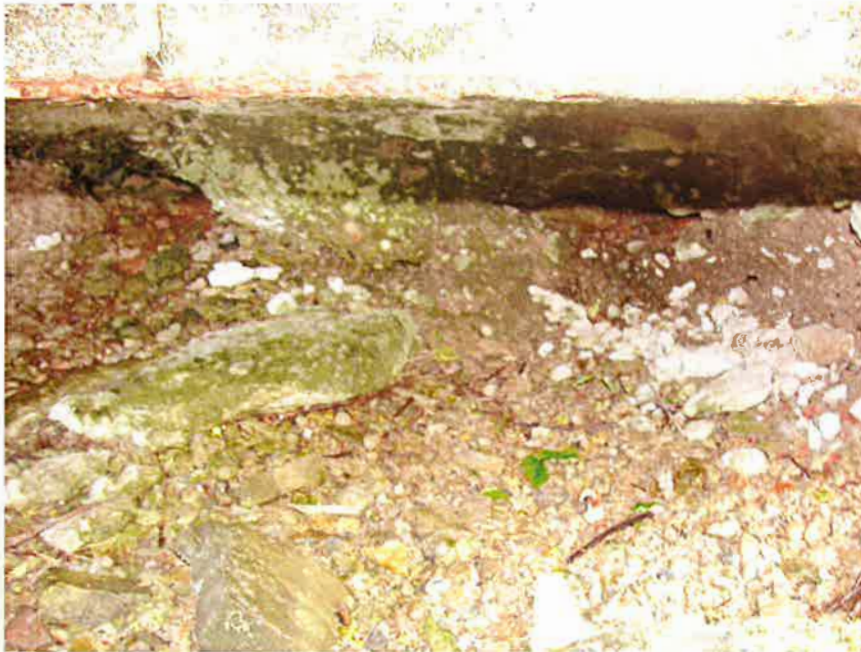
Photo 8. View from under DS right (south) side of spillway slab, 2012 photo. No seepage.

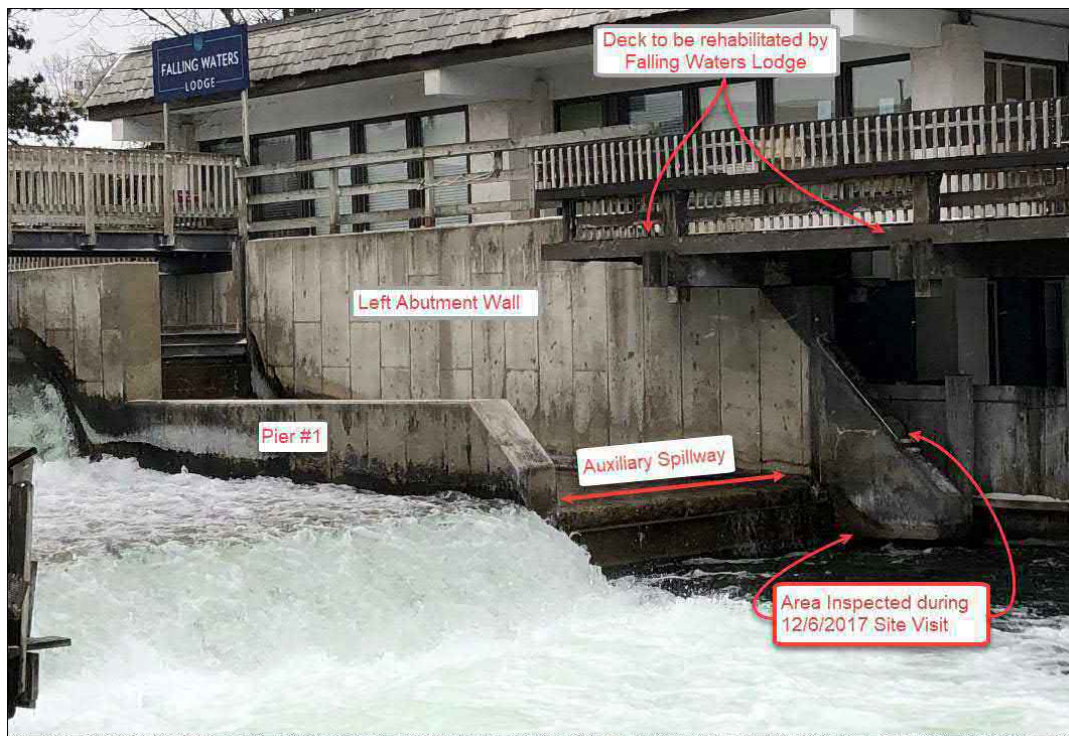
Looking South at Auxiliary Spillway, Left Abutment Wall
