LELAND DAM INSPECTION

Dam Identification No.: 510
Hazard Potential: High
NE Quarter of Section 9, T. 30 N. – R.12 W
Leelanau County, Michigan
Lake Leelanau

Date of Inspection: September 1, 2022
Date of Report: October 2022

Project I.D. Number 131999SG2022

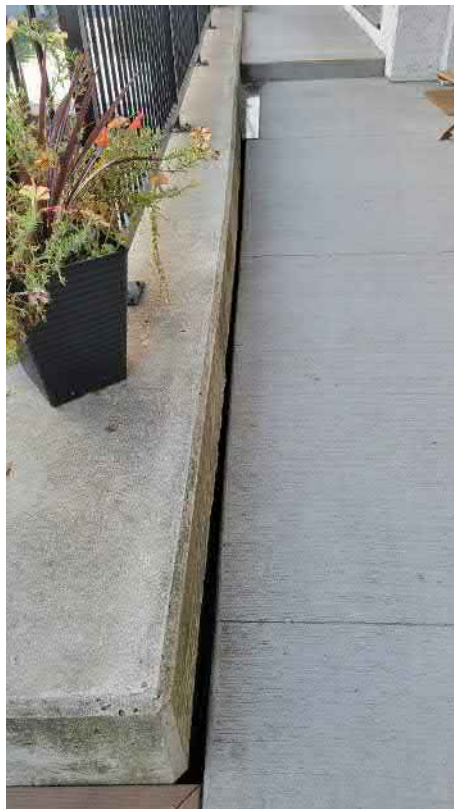
Gap between Sidewalk and Left Abutment Wall

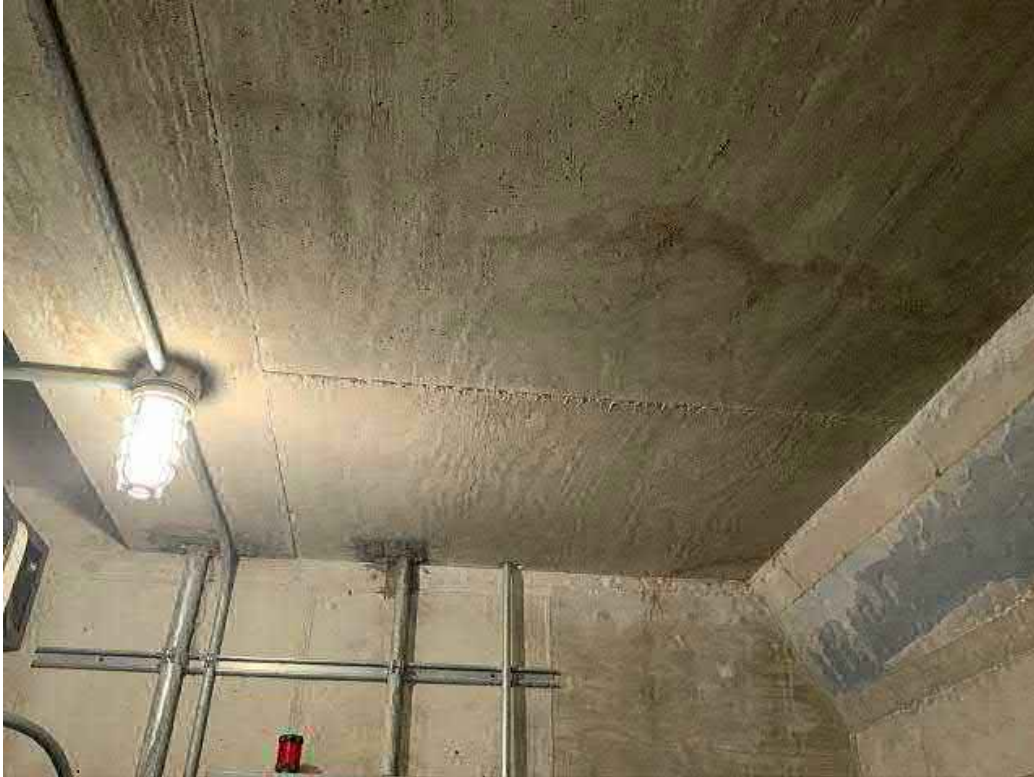
Looking northeast at ceiling of hydraulics / control room.

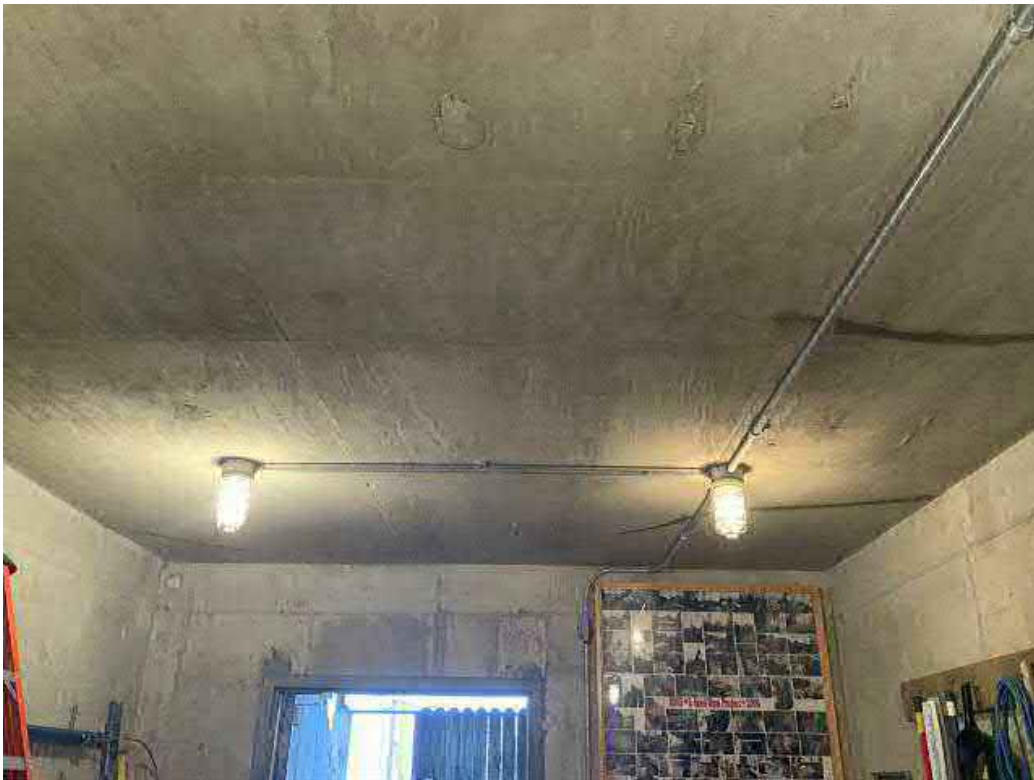
Looking northwest at ceiling within hydraulic / control room.

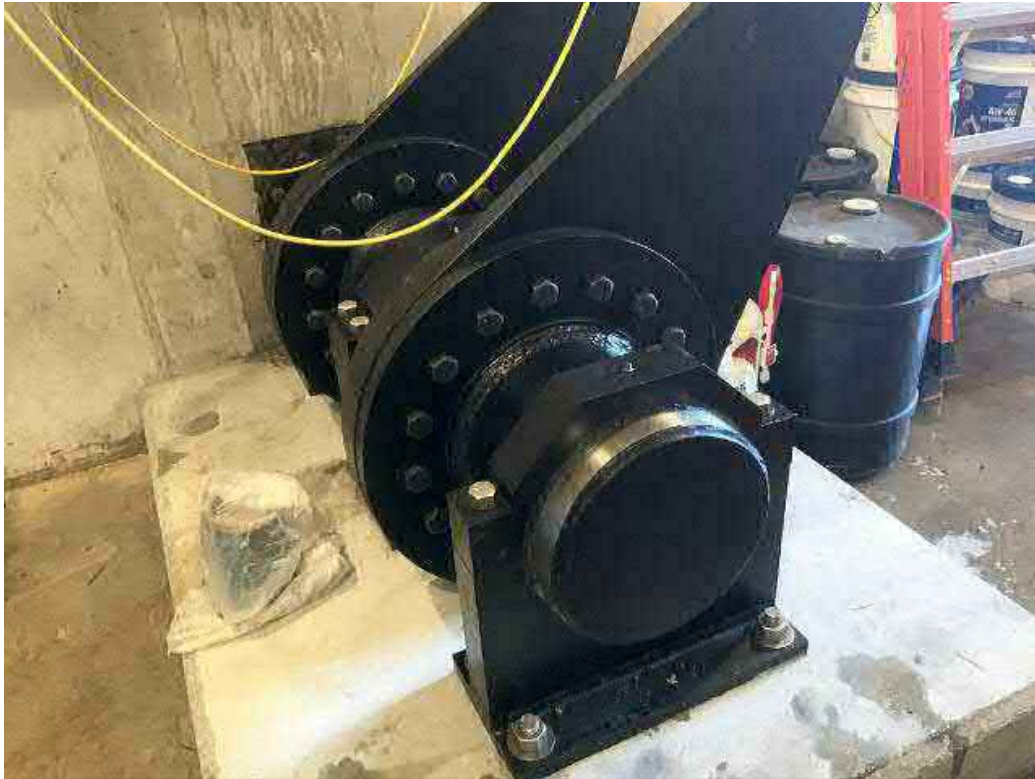
Torque arm - bearings and bearing mounts.

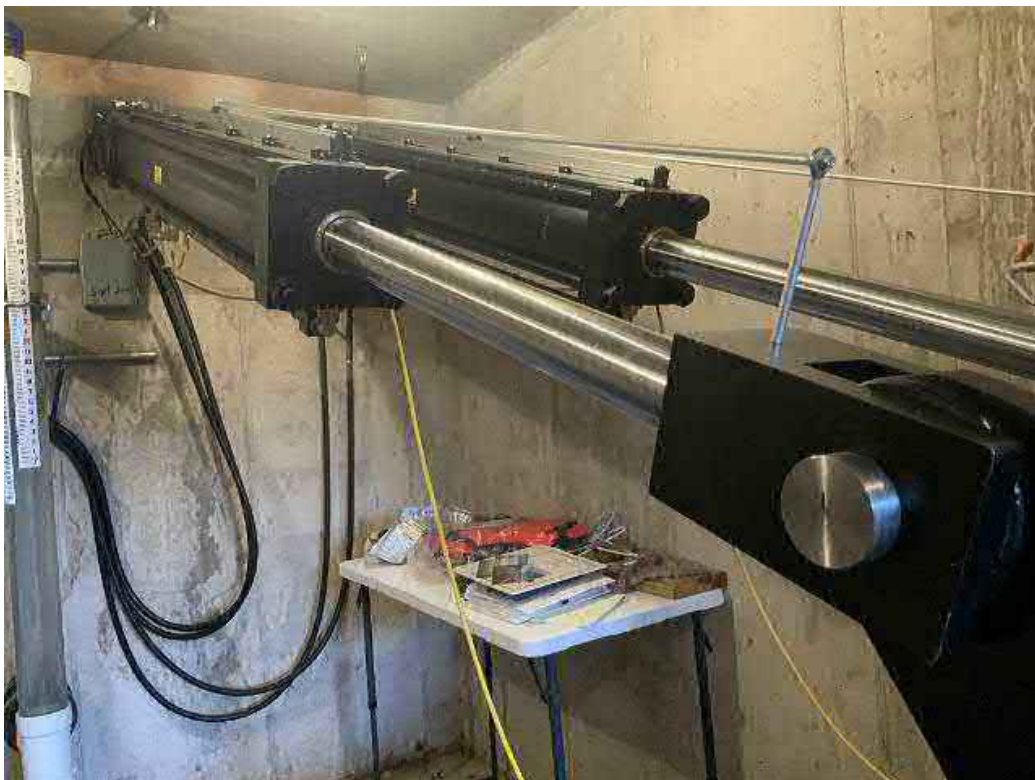
Hydraulic rams.

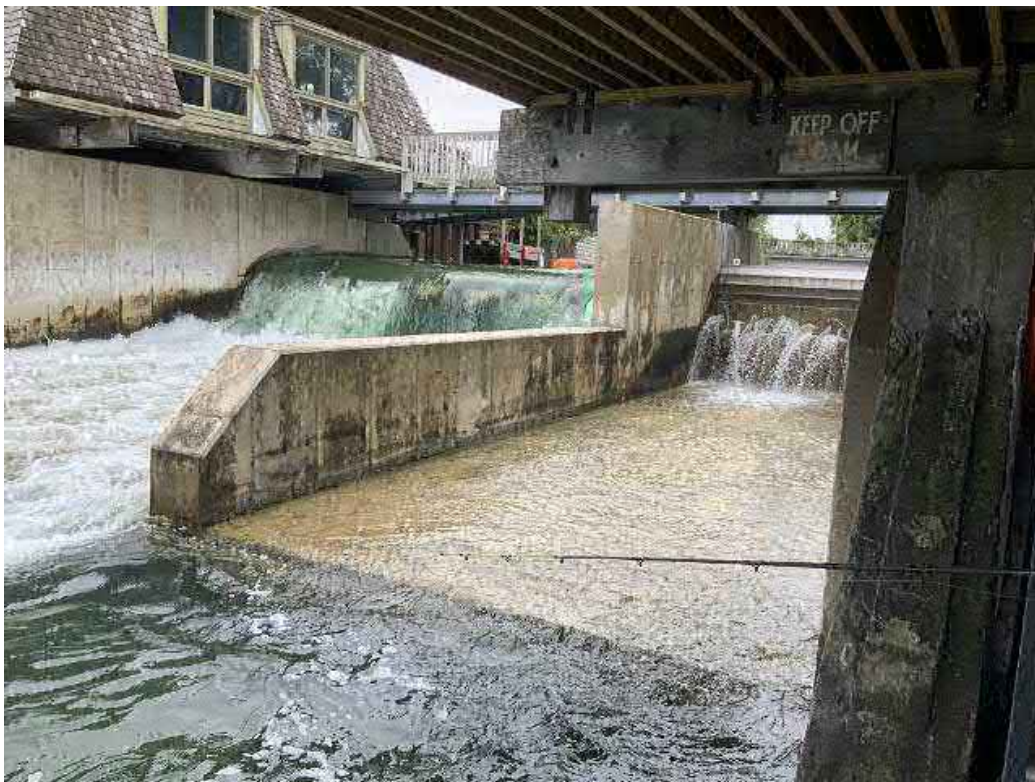
Looking east across downstream end of Bay #1 spillway.

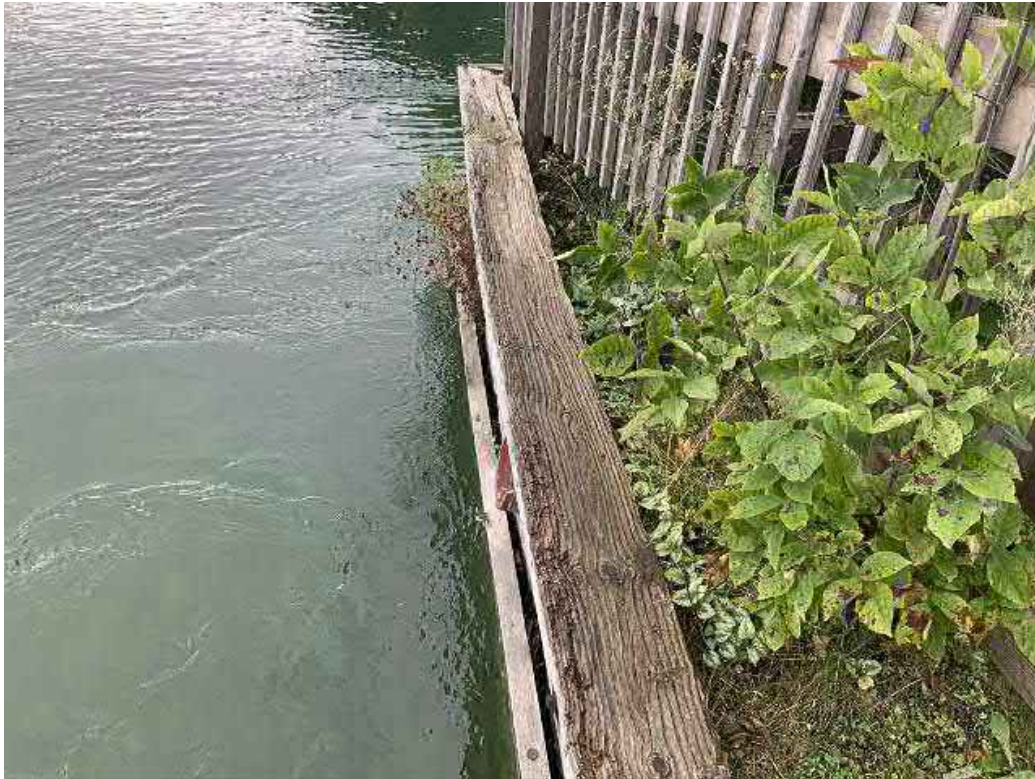
Looking northwest at wooden seawall from northwest (upstream) end of left abutment wall.

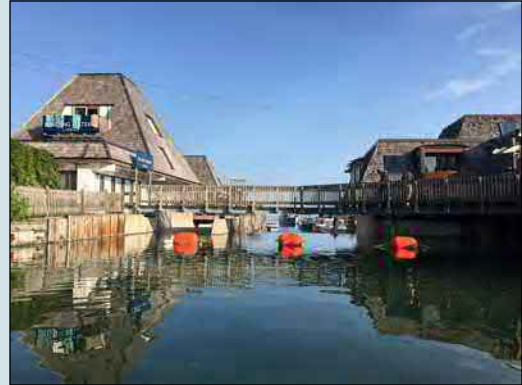
Safety boom

There is a floating safety boom on the upstream end of the dam to keep recreational boats and swimmers away from the upstream end of the dam.

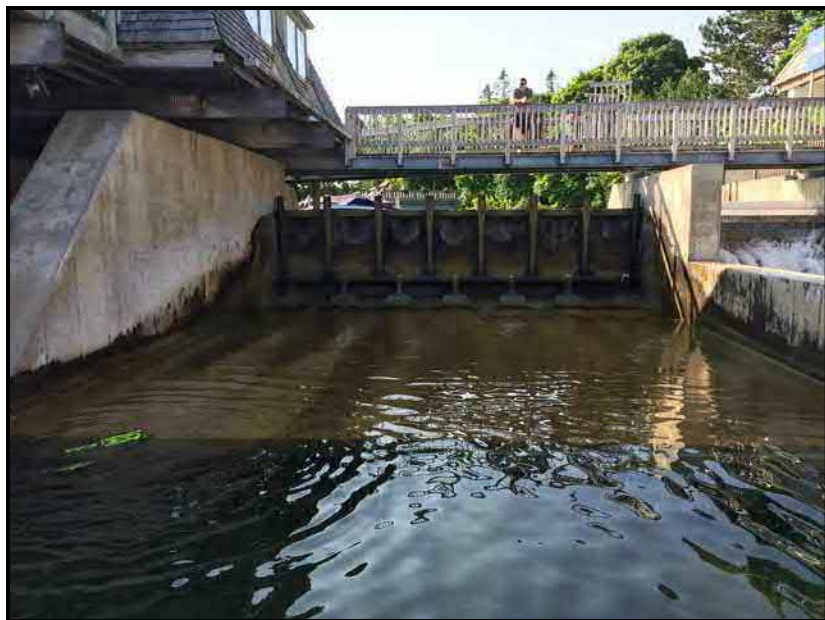
There is a section of timber wakefield wall upstream of the upstream steel sheet wall. No undermining was found, but settlement was observed behind the wall.

*Upstream left
timber wall*

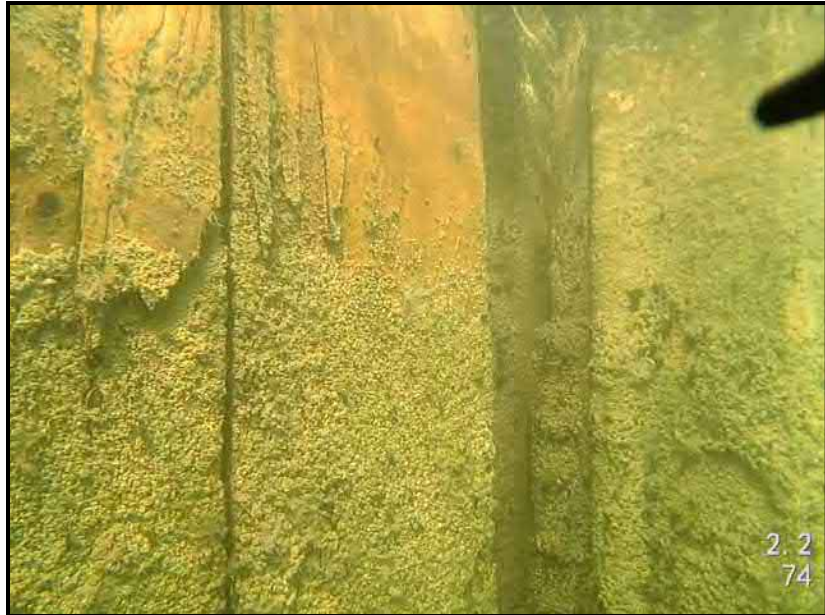
There is a section steel sheet wall upstream of the left abutment that is in fair condition with surface rust above the waterline. It is coated with a chalky sediment up to 1/2" thick. The steel sheeting is in good condition where the sediment was removed. There is no undermining of the steel wall.

*Upstream left
steel sheet wall*

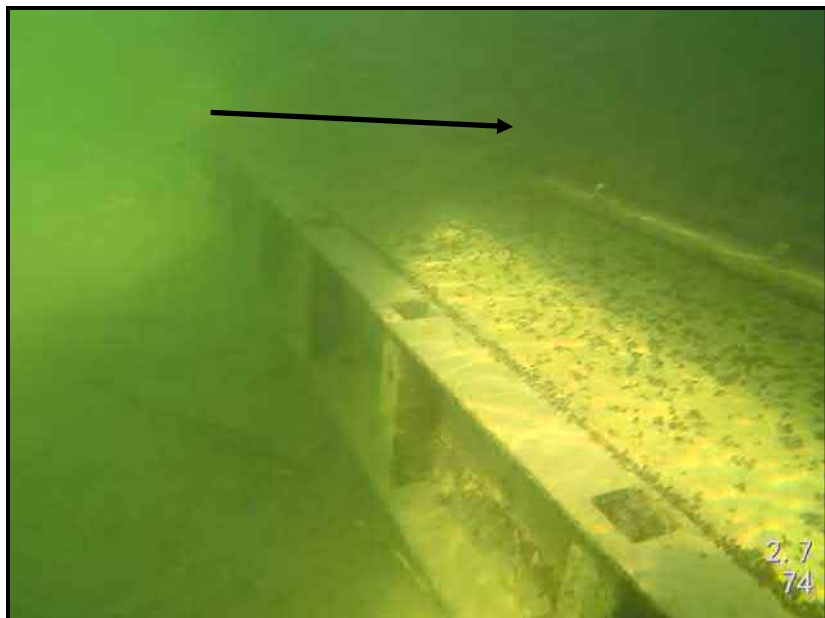
Upstream pier
3

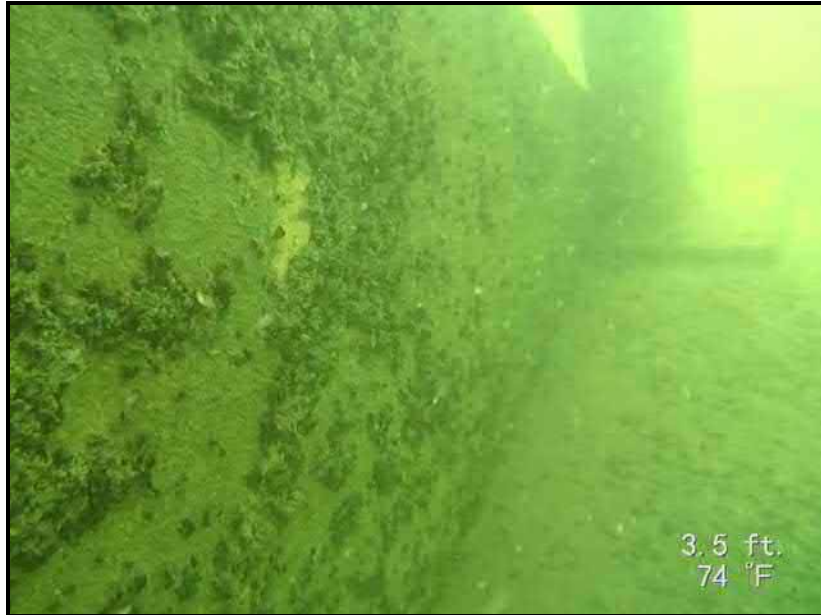
*Upstream right
abutment*

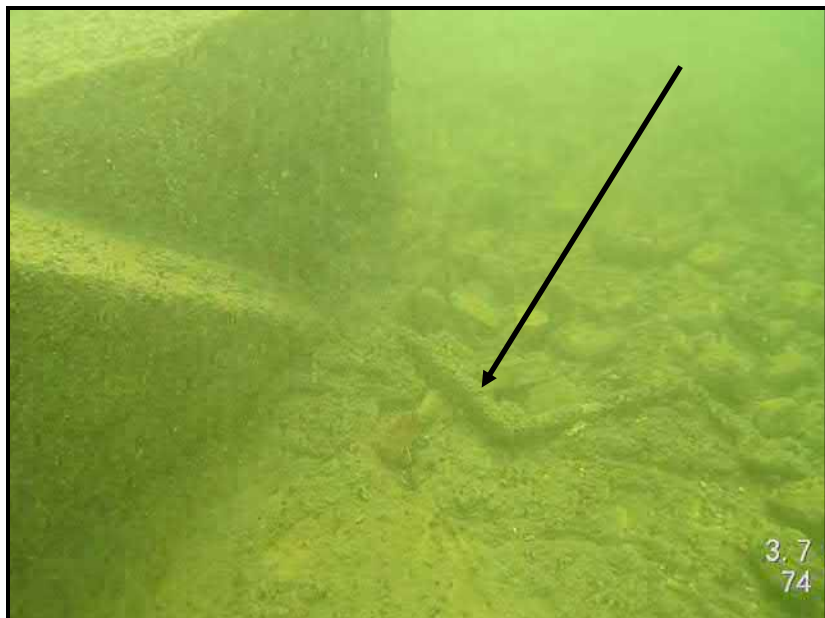
*Downstream
left abutment
under spillway
overhang*

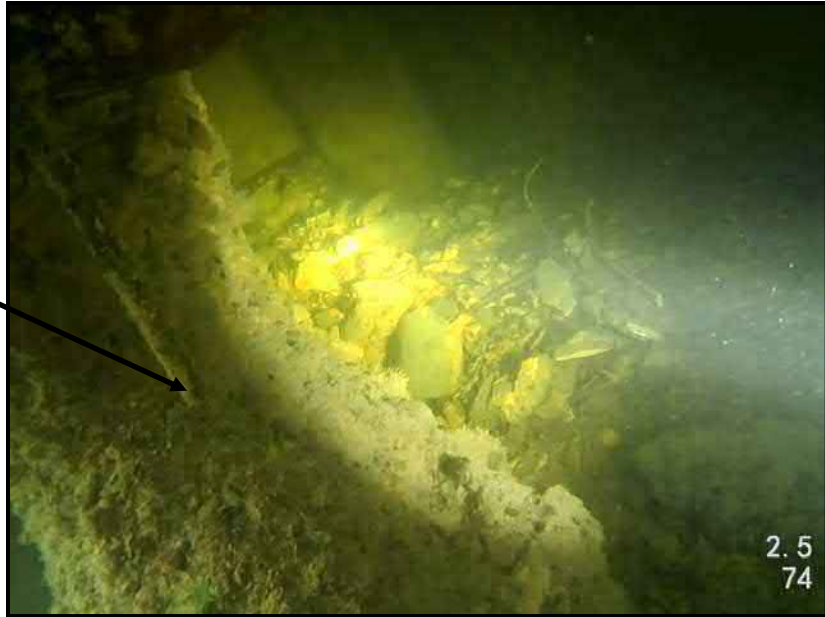
*Downstream
spillway
overhang at
left abutment*

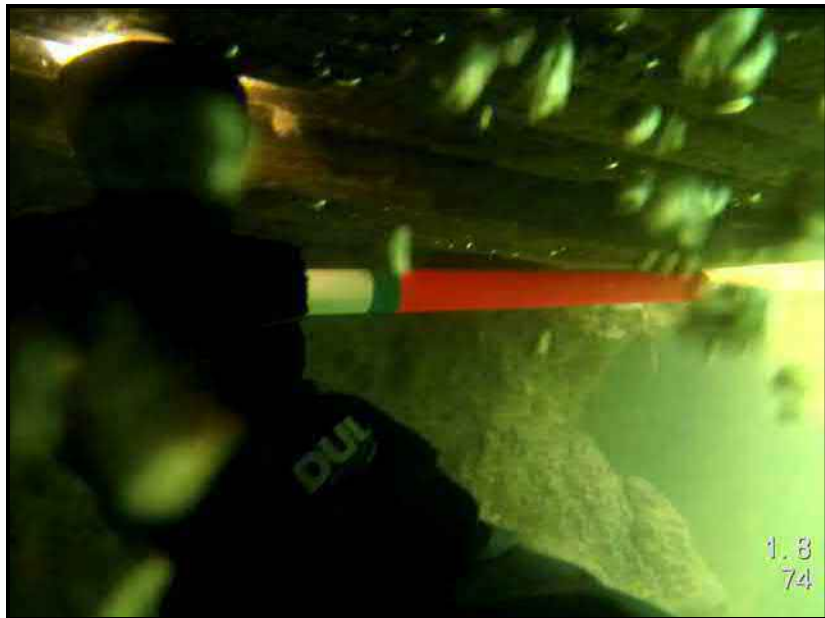
*Undermined
cutoff wall in
bay 3*

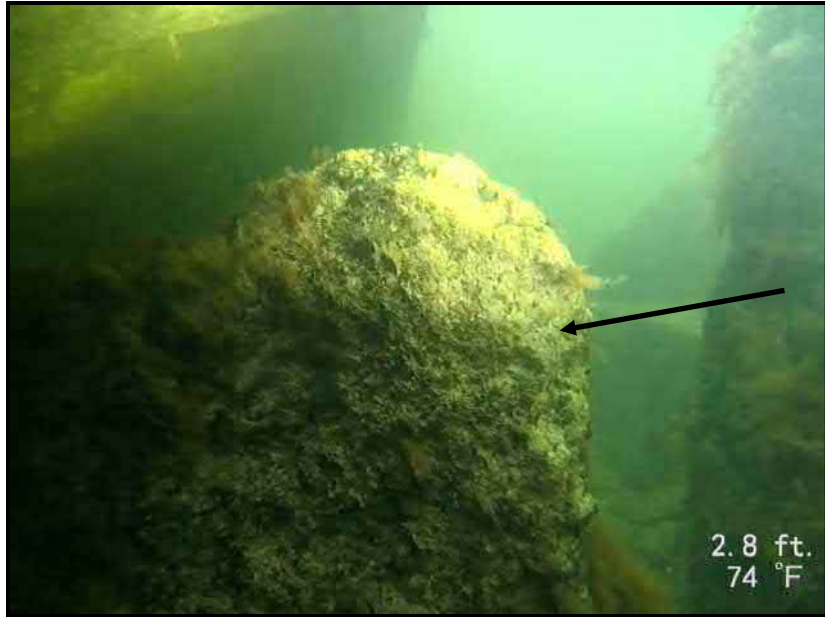
*Downstream
scour wall pier
3*

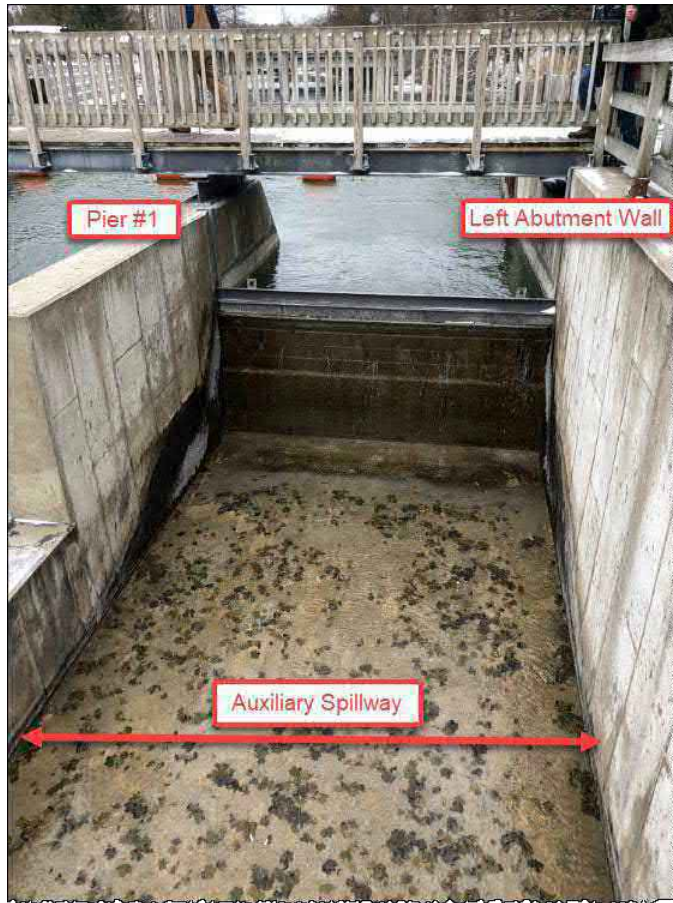
Looking Upstream at Auxiliary Spillway
